### NSPIRE: Other

Scheduled: 11/13/2023

Score: 57.88

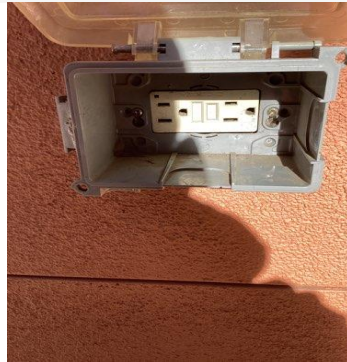
| Outside | | | | | | | | | | | |
|---|---|---|---|---|---|---|---|---|---|---|---|
| | Exterior Wall | Conductors, Outlets, Switches | Exposed electrical conductor | Back East side of building, needs zipties | <u>1</u> | 11/13/23 13:56 SC | | LT | 1.77 | 1.27 | 24H |

1 - Exterior Wall - Conductors, Outlets, Switches - Nov 13 2023 1:56PM - [REDACTED] CAPTION: Back East side of building, needs zip ties

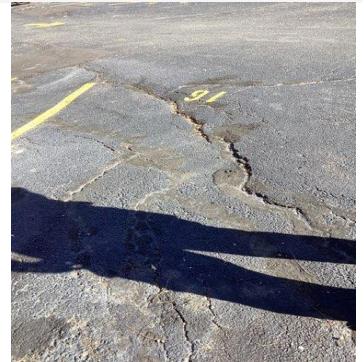
3

| Outside | | | | | | | | | | | |
|---|---|---|---|---|---|---|---|---|---|---|---|
| | Parking Lot | Tripping Hazard | Tripping hazard - 2in. horizontal separation | Back parking lot | <u>3</u> | 11/13/23 14:01 SC | | Mod | 0.16 | 0.12 <sup>3</sup> | 30D |

1 - Parking Lot - Tripping Hazard - Nov 13 2023 2:01PM - [REDACTED] CAPTION: Back parking lot

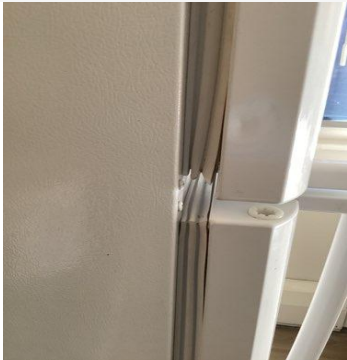
| Kitchen | Refrigerator | Refrigerator door seal is damaged | | | <a href="#">13</a> | 11/13/23 13:32 SC | | Mod | 0.20 | 0.14 | 30D |

1 Unit 0201 - Kitchen - Refrigerator - Nov  
13 2023 1:32PM -

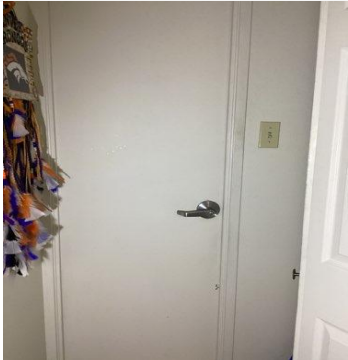
15

| Bathroom 1 | Door – General | A passage door component is damaged/missing/inoperable | Bathroom door doesnt latch | | <a href="#">15</a> | 11/13/23 13:26 SC | | Low | 0.09 | 0.06 | 60D |

1 Unit 0212 - Bathroom 1 - Door -  
General - Nov 13 2023 1:26PM -  
CAPTION: Bathroom door doesnt latch

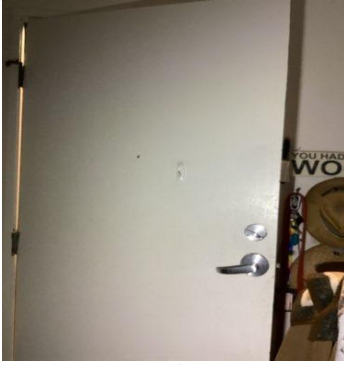
16

| Alternate Location - See Notes for Details | Door Hardware - Entry (non-fire) | Entry door self-closing mechanism is damaged or inoperable | | | <a href="#">16</a> | 11/13/23 13:18 SC | | Mod | 0.20 | 0.14 | 30D |

1 Unit 0214 - Alternate Location - See Notes for Details - Door Hardware - Entry (non-fire) - Nov 13 2023 1:18PM - [REDACTED]

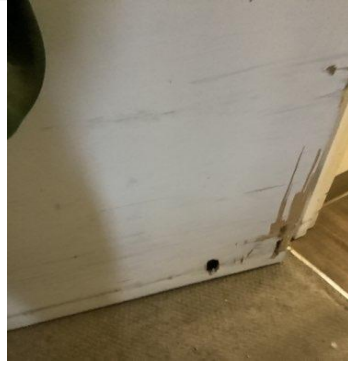
17

| Bedroom 1 | Door – General | A passage door component is damaged/missing/inoperable | | | <a href="#">17</a> | 11/13/23 13:20 SC | | Low | 0.09 | 0.06 | 60D |

1 Unit 0214 - Bedroom 1 - Door – General - Nov 13 2023 1:20PM - [REDACTED]

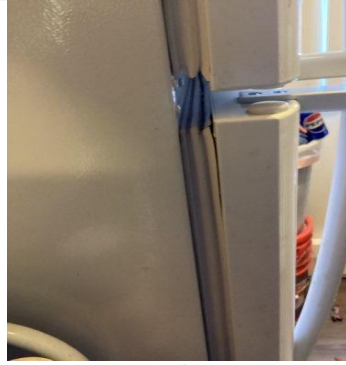
| Location | Item | Results | Notes | Pic | Date | Fixed | Sev | HUD Pts | Adj Pts | Fix By |
|---|---|---|---|---|---|---|---|---|---|---|
| Kitchen | Refrigerator | Refrigerator door seal is damaged | | 18 | 11/13/23<br>13:21 SC | | Mod | 0.20 | 0.14 | 30D |

1 Unit 0214 - Kitchen - Refrigerator - Nov 13 2023 1:21PM - [REDACTED]

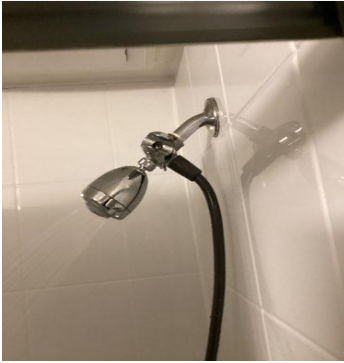
| Location | Item | Results | Notes | Pic | Date | Fixed | Sev | HUD Pts | Adj Pts | Fix By |
|---|---|---|---|---|---|---|---|---|---|---|
| Bathroom 1 | Bathtub/Shower | Bath/shower components damaged, missing, or inoperable | | 19 | 11/13/23<br>13:07 SC | | Mod | 0.20 | 0.14 | 30D |

1 Unit 0304 - Bathroom 1 - Bathtub/Shower - Nov 13 2023 1:07PM - [REDACTED]

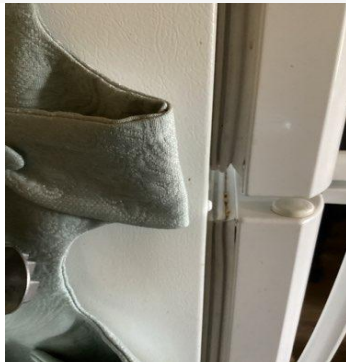
26

| Location | Item | Results | Notes | Pic | Date | Fixed | Sev | HUD Pts | Adj Pts | Fix By |
|---|---|---|---|---|---|---|---|---|---|---|
| Kitchen | Refrigerator | Refrigerator door seal is damaged | | <a href="#">26</a> | 11/13/23<br>12:51 SC | | Mod | 0.20 | 0.14 | 30D |

1 Unit 0406 - Kitchen - Refrigerator - Nov 13 2023 12:51PM - [REDACTED]

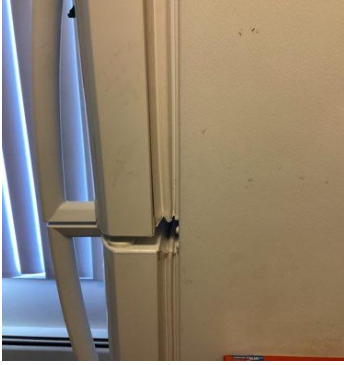
27

| Location | Item | Results | Notes | Pic | Date | Fixed | Sev | HUD Pts | Adj Pts | Fix By |
|---|---|---|---|---|---|---|---|---|---|---|
| Kitchen | Refrigerator | Refrigerator door seal is damaged | | <a href="#">27</a> | 11/13/23<br>12:41 SC | | Mod | 0.20 | 0.14 | 30D |

1 Unit 0510 - Kitchen - Refrigerator - Nov  
13 2023 12:41PM - [REDACTED]

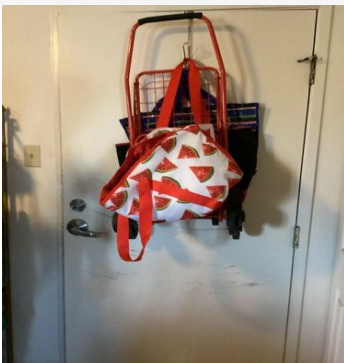
28

| Location | Item | Results | Notes | Pic | Date | Fixed | Sev | HUD Pts | Adj Pts | Fix By |
|---|---|---|---|---|---|---|---|---|---|---|
| Alternate Location - See Notes for Details | Door Hardware - Entry (non-fire) | Entry door self-closing mechanism is damaged or inoperable | | <a href="#">28</a> | 11/13/23<br>12:45 SC | | Mod | 0.20 | 0.14 | 30D |

1 Unit 0516 - Alternate Location - See  
Notes for Details - Door Hardware - Entry  
(non-fire) - Nov 13 2023 12:45PM - [REDACTED]

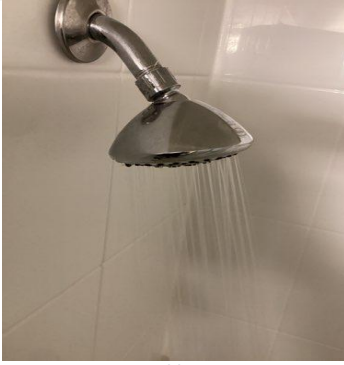
30

| Location | Item | Results | Notes | Pic | Date | Fixed | Sev | HUD Pts | Adj Pts | Fix By |
|---|---|---|---|---|---|---|---|---|---|---|
| Bathroom 1 | Bathtub/Shower | Bath/shower components damaged, missing, or inoperable | | <a href="#">30</a> | 11/13/23<br>11:45 SC | | Mod | 0.20 | 0.14 | 30D |

1 Unit 0607 - Bathroom 1 - Bathtub/Shower - Nov 13 2023 11:45AM - [REDACTED]

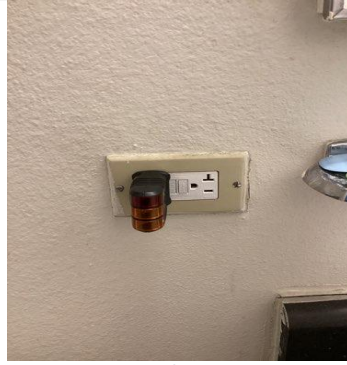
31

| Location | Item | Results | Notes | Pic | Date | Fixed | Sev | HUD Pts | Adj Pts | Fix By |
|---|---|---|---|---|---|---|---|---|---|---|
| Bathroom 1 | GFCI/AFCI | GFCI outlet or GFCI breaker reset button does not test (No visible damage) | | <a href="#">31</a> | 11/13/23<br>11:45 SC | | Severe | 0.53 | 0.38 | 24H |

1 Unit 0607 - Bathroom 1 - GFCI/AFCI - Nov 13 2023 11:45AM - [REDACTED]

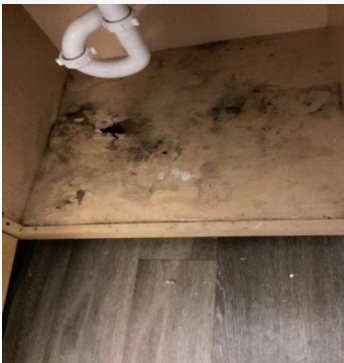
35

| Location | Item | Results | Notes | Pic | Date | Fixed | Sev | HUD Pts | Adj Pts | Fix By |
|---|---|---|---|---|---|---|---|---|---|---|
| Bathroom 1 | Cabinets/Vanity | 50%+ of cabinet components are missing/damaged/inoperable in a bathroom or laundry | | <a href="#">35</a> | 11/13/23 11:21 SC | | Mod | 0.20 | 0.14 | 30D |

1 Unit 0712 - Bathroom 1 - Cabinets/Vanity - Nov 13 2023 11:21AM - [REDACTED]

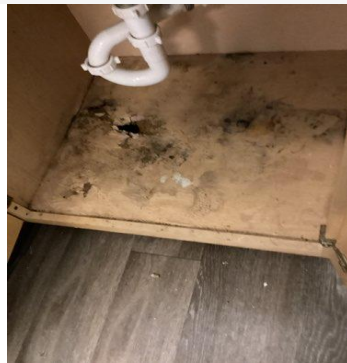
36

| Location | Item | Results | Notes | Pic | Date | Fixed | Sev | HUD Pts | Adj Pts | Fix By |
|---|---|---|---|---|---|---|---|---|---|---|
| Bathroom 1 | Mold-Like Substances | Moisture damage on a surface from 1 to 9 S.F. (Units) | | <a href="#">36</a> | 11/13/23 11:21 SC | | Severe | 0.53 | 0.38 | 24H |

1 Unit 0712 - Bathroom 1 - Mold-Like Substances - Nov 13 2023 11:21AM - [REDACTED]

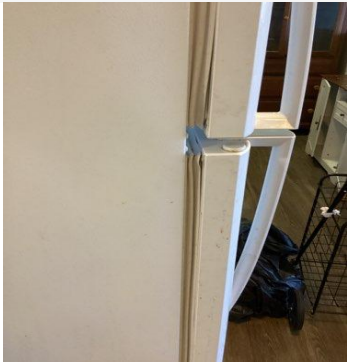
39

| Location | Item | Results | Notes | Pic | Date | Fixed | Sev | HUD Pts | Adj Pts | Fix By |
|---|---|---|---|---|---|---|---|---|---|---|
| Kitchen | Refrigerator | Refrigerator door seal is damaged | | <a href="#">39</a> | 11/13/23 11:25 SC | | Mod | 0.20 | 0.14 | 30D |

1 Unit 0712 - Kitchen - Refrigerator - Nov 13 2023 11:25AM -

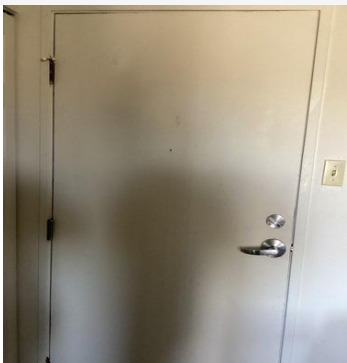
40

| Location | Item | Results | Notes | Pic | Date | Fixed | Sev | HUD Pts | Adj Pts | Fix By |
|---|---|---|---|---|---|---|---|---|---|---|
| Alternate Location - See Notes for Details | Door Hardware - Entry (non-fire) | Entry door self-closing mechanism is damaged or inoperable | | <a href="#">40</a> | 11/13/23 11:00 SC | | Mod | 0.20 | 0.14 | 30D |

1 Unit 0801 - Alternate Location - See Notes for Details - Door Hardware - Entry (non-fire) - Nov 13 2023 11:00AM -

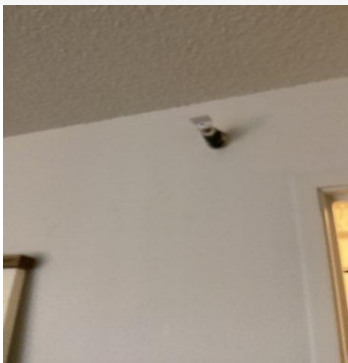
41

| Location | Item | Results | Notes | Pic | Date | Fixed | Sev | HUD Pts | Adj Pts | Fix By |
|---|---|---|---|---|---|---|---|---|---|---|
| Bedroom 1 | Sprinkler Assembly | Sprinkler assembly component is missing or damaged | | <a href="#">41</a> | 11/13/23 11:01 SC | | LT | 2.14 | 1.54 | 24H |

1 Unit 0801 - Bedroom 1 - Sprinkler Assembly - Nov 13 2023 11:01AM -

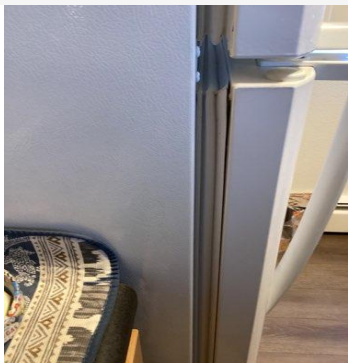
42

| Location | Item | Results | Notes | Pic | Date | Fixed | Sev | HUD Pts | Adj Pts | Fix By |
|---|---|---|---|---|---|---|---|---|---|---|
| Kitchen | Refrigerator | Refrigerator door seal is damaged | | <a href="#">42</a> | 11/13/23 11:03 SC | | Mod | 0.20 | 0.14 | 30D |

1 Unit 0801 - Kitchen - Refrigerator - Nov 13 2023 11:03AM -

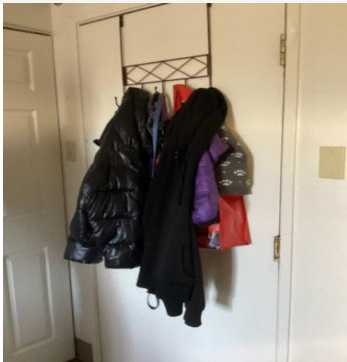
43

| Location | Item | Results | Notes | Pic | Date | Fixed | Sev | HUD Pts | Adj Pts | Fix By |
|---|---|---|---|---|---|---|---|---|---|---|
| Alternate Location - See Notes for Details | Door Hardware - Entry (non-fire) | Entry door self-closing mechanism is damaged or inoperable | | <a href="#">43</a> | 11/13/23 11:05 SC | | Mod | 0.20 | 0.14 | 30D |

1 Unit 0809 - Alternate Location - See Notes for Details - Door Hardware - Entry (non-fire) - Nov 13 2023 11:05AM -

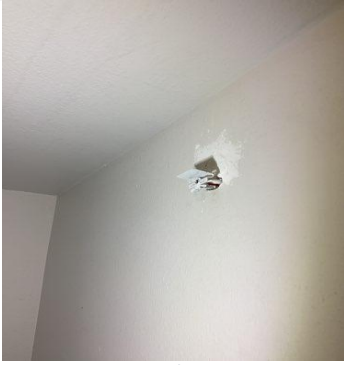
49

| Location | Item | Results | Notes | Pic | Date | Fixed | Sev | HUD Pts | Adj Pts | Fix By |
|---|---|---|---|---|---|---|---|---|---|---|
| Bedroom 1 | Sprinkler Assembly | Sprinkler assembly component is missing or damaged | | <a href="#">49</a> | 11/13/23 10:50 SC | | LT | 2.14 | 1.54 <sup>3</sup> | 24H |
| Bedroom 1 | Sprinkler Assembly | Sprinkler head escutcheon is missing | | <a href="#">49</a> | 11/13/23 10:50 SC | | LT | 2.14 | 1.54 <sup>3</sup> | 24H |

1 Unit 0913 - Bedroom 1 - Sprinkler Assembly - Nov 13 2023 10:50AM - [REDACTED]

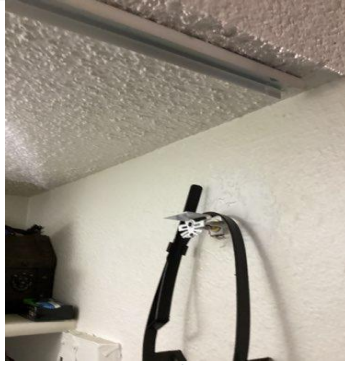
50

| Location | Item | Results | Notes | Pic | Date | Fixed | Sev | HUD Pts | Adj Pts | Fix By |
|---|---|---|---|---|---|---|---|---|---|---|
| Hallways & Corridors | Sprinkler Assembly | Sprinkler head escutcheon is missing | | <a href="#">50</a> | 11/13/23 10:51 SC | | LT | 2.14 | 1.54 <sup>3</sup> | 24H |
| Hallways & Corridors | Sprinkler Assembly | Sprinkler assembly component is missing or damaged | | <a href="#">50</a> | 11/13/23 10:51 SC | | LT | 2.14 | 1.54 <sup>3</sup> | 24H |

1 Unit 0913 - Hallways & Corridors - Sprinkler Assembly - Nov 13 2023 10:51AM - [REDACTED]

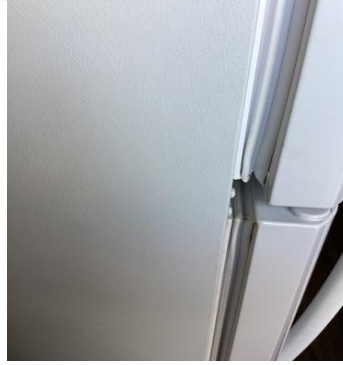
51

| Location | Item | Results | Notes | Pic | Date | Fixed | Sev | HUD Pts | Adj Pts | Fix By |
|---|---|---|---|---|---|---|---|---|---|---|
| Kitchen | Refrigerator | Refrigerator door seal is damaged | | <a href="#">51</a> | 11/13/23 10:49 SC | | Mod | 0.20 | 0.14 | 30D |

1 Unit 0913 - Kitchen - Refrigerator - Nov 13 2023 10:49AM - [REDACTED]

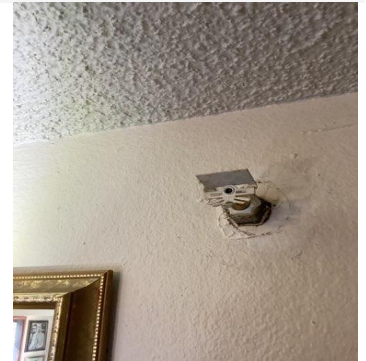
55

| Location | Item | Results | Notes | Pic | Date | Fixed | Sev | HUD Pts | Adj Pts | Fix By |
|---|---|---|---|---|---|---|---|---|---|---|
| Bedroom 1 | Sprinkler Assembly | Sprinkler assembly component is missing or damaged | | <a href="#">55</a> | 11/13/23 10:18 SC | | LT | 2.14 | 1.54 | 24H |

1 Unit 1004 - Bedroom 1 - Sprinkler Assembly - Nov 13 2023 10:18AM - [REDACTED]

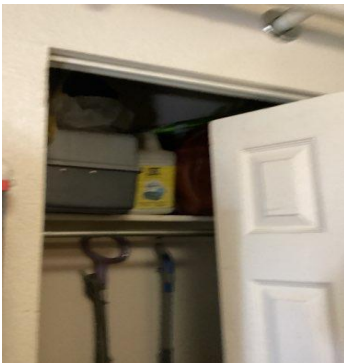
56

| Location | Item | Results | Notes | Pic | Date | Fixed | Sev | HUD Pts | Adj Pts | Fix By |
|---|---|---|---|---|---|---|---|---|---|---|
| Hallways & Corridors | Door – General | Closet door component is missing, damaged or inoperable | | <a href="#">56</a> | 11/13/23 10:16 SC | | Low | 0.09 | 0.06 | 60D |

1 Unit 1004 - Hallways & Corridors - Door - General - Nov 13 2023 10:16AM - [REDACTED]

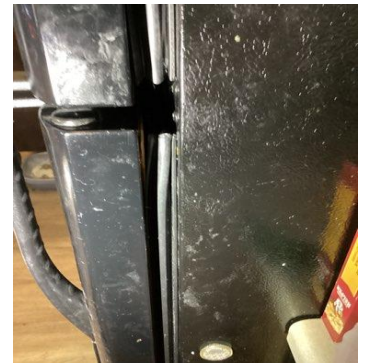
59

| Location | Item | Results | Notes | Pic | Date | Fixed | Sev | HUD Pts | Adj Pts | Fix By |
|---|---|---|---|---|---|---|---|---|---|---|
| Kitchen | Refrigerator | Refrigerator door seal is damaged | | <a href="#">59</a> | 11/13/23 10:20 SC | | Mod | 0.20 | 0.14 | 30D |

1 Unit 1004 - Kitchen - Refrigerator - Nov 13 2023 10:20AM - [REDACTED]

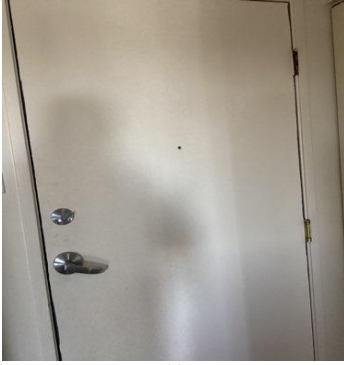
60

| Location | Item | Results | Notes | Pic | Date | Fixed | Sev | HUD Pts | Adj Pts | Fix By |
|---|---|---|---|---|---|---|---|---|---|---|
| Alternate Location - See Notes for Details | Door Hardware - Entry (non-fire) | Entry door self-closing mechanism is damaged or inoperable | | <a href="#">60</a> | 11/13/23 10:22 SC | | Mod | 0.20 | 0.14 | 30D |

1 Unit 1006 - Alternate Location - See Notes for Details - Door Hardware - Entry (non-fire) - Nov 13 2023 10:22AM - [REDACTED]

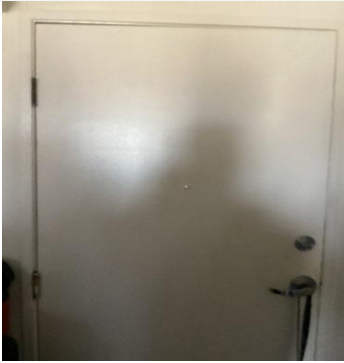
62

| Location | Item | Results | Notes | Pic | Date | Fixed | Sev | HUD Pts | Adj Pts | Fix By |
|---|---|---|---|---|---|---|---|---|---|---|
| Alternate Location - See Notes for Details | Door Hardware - Entry (non-fire) | Entry door self-closing mechanism is damaged or inoperable | | <a href="#">62</a> | 11/13/23 10:26 SC | | Mod | 0.20 | 0.14 | 30D |

1 Unit 1007 - Alternate Location - See Notes for Details - Door Hardware - Entry (non-fire) - Nov 13 2023 10:26AM - [REDACTED]

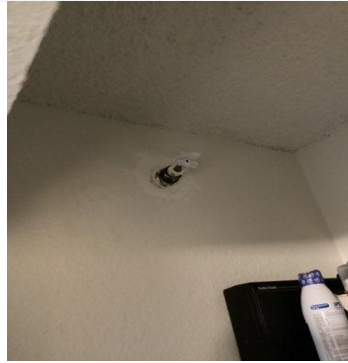
63

| Location | Item | Results | Notes | Pic | Date | Fixed | Sev | HUD Pts | Adj Pts | Fix By |
|---|---|---|---|---|---|---|---|---|---|---|
| Bedroom 1 | Sprinkler Assembly | Sprinkler assembly component is missing or damaged | | <a href="#">63</a> | 11/13/23 10:29 SC | | LT | 2.14 | 1.54 | 24H |

1 Unit 1007 - Bedroom 1 - Sprinkler Assembly - Nov 13 2023 10:29AM - [REDACTED]

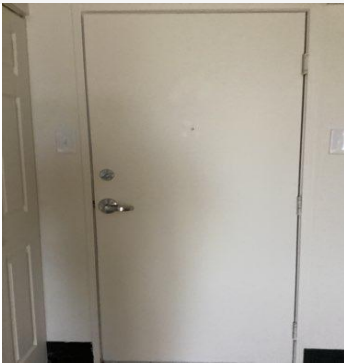
64

| Location | Item | Results | Notes | Pic | Date | Fixed | Sev | HUD Pts | Adj Pts | Fix By |
|---|---|---|---|---|---|---|---|---|---|---|
| Alternate Location - See Notes for Details | Door Hardware - Entry (non-fire) | Entry door self-closing mechanism is damaged or inoperable | | <a href="#">64</a> | 11/13/23 10:30 SC | | Mod | 0.20 | 0.14 | 30D |

1 Unit 1008 - Alternate Location - See Notes for Details - Door Hardware - Entry (non-fire) - Nov 13 2023 10:30AM - [REDACTED]

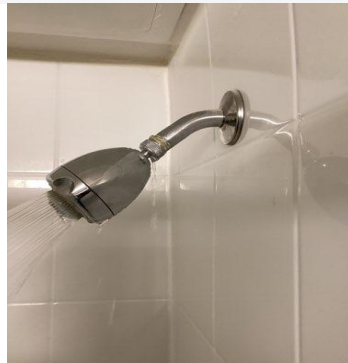
65

| Location | Item | Results | Notes | Pic | Date | Fixed | Sev | HUD Pts | Adj Pts | Fix By |
|---|---|---|---|---|---|---|---|---|---|---|
| Bathroom 1 | Bathtub/Shower | Bath/shower components damaged, missing, or inoperable | | <a href="#">65</a> | 11/13/23 10:31 SC | | Mod | 0.20 | 0.14 | 30D |

1 Unit 1008 - Bathroom 1 - Bathtub/Shower - Nov 13 2023 10:31AM - [REDACTED]

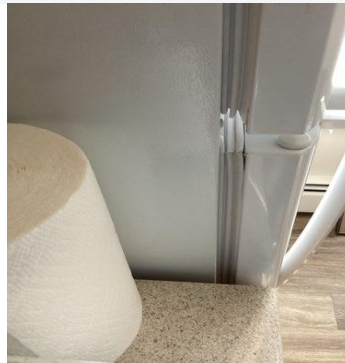
66

| Location | Item | Results | Notes | Pic | Date | Fixed | Sev | HUD Pts | Adj Pts | Fix By |
|---|---|---|---|---|---|---|---|---|---|---|
| Kitchen | Refrigerator | Refrigerator door seal is damaged | | <a href="#">66</a> | 11/13/23 10:34 SC | | Mod | 0.20 | 0.14 | 30D |

1 Unit 1008 - Kitchen - Refrigerator - Nov 13 2023 10:34AM - [REDACTED]

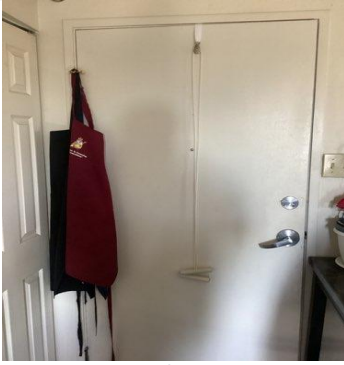
67

| Location | Item | Results | Notes | Pic | Date | Fixed | Sev | HUD Pts | Adj Pts | Fix By |
|---|---|---|---|---|---|---|---|---|---|---|
| Alternate Location - See Notes for Details | Door Hardware - Entry (non-fire) | Entry door self-closing mechanism is damaged or inoperable | | <a href="#">67</a> | 11/13/23 10:36 SC | | Mod | 0.20 | 0.14 | 30D |

1 Unit 1014 - Alternate Location - See Notes for Details - Door Hardware - Entry (non-fire) - Nov 13 2023 10:36AM - [REDACTED]

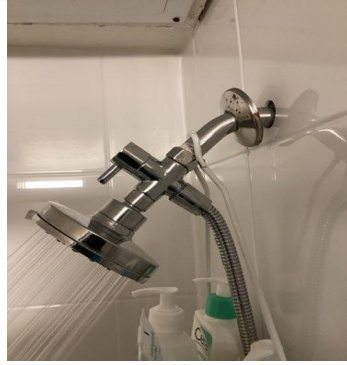
68

| Location | Item | Results | Notes | Pic | Date | Fixed | Sev | HUD Pts | Adj Pts | Fix By |
|---|---|---|---|---|---|---|---|---|---|---|
| Bathroom 1 | Bathtub/Shower | Bath/shower components damaged, missing, or inoperable | | <a href="#">68</a> | 11/13/23 10:37 SC | | Mod | 0.20 | 0.14 | 30D |

1 Unit 1014 - Bathroom 1 - Bathtub/Shower - Nov 13 2023 10:37AM - [REDACTED]

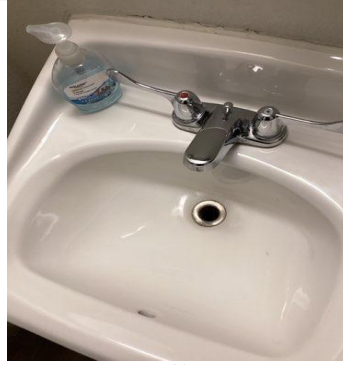
69

| Location | Item | Results | Notes | Pic | Date | Fixed | Sev | HUD Pts | Adj Pts | Fix By |
|---|---|---|---|---|---|---|---|---|---|---|
| Bathroom 1 | Sink | Sink stopper missing or inoperable | | <a href="#">69</a> | 11/13/23 10:36 SC | | Low | 0.09 | 0.06 | 60D |

1 Unit 1014 - Bathroom 1 - Sink - Nov 13 2023 10:36AM - [REDACTED]

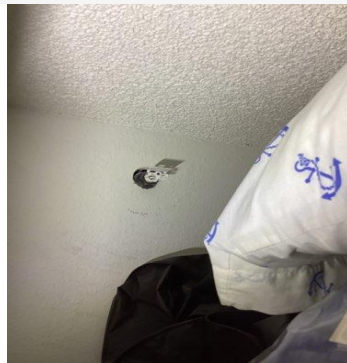
74

| Location | Item | Results | Notes | Pic | Date | Fixed | Sev | HUD Pts | Adj Pts | Fix By |
|---|---|---|---|---|---|---|---|---|---|---|
| Bedroom 1 | Sprinkler Assembly | Sprinkler assembly component is missing or damaged | | <a href="#">74</a> | 11/13/23 10:11 SC | | LT | 2.14 | 1.54 | 24H |

1 Unit 1101 - Bedroom 1 - Sprinkler Assembly - Nov 13 2023 10:11AM - [REDACTED]

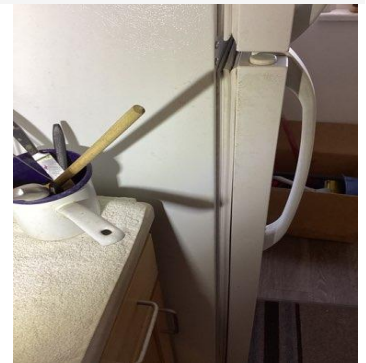
76

| Location | Item | Results | Notes | Pic | Date | Fixed | Sev | HUD Pts | Adj Pts | Fix By |
|---|---|---|---|---|---|---|---|---|---|---|
| Kitchen | Refrigerator | Refrigerator door seal is damaged | | <a href="#">76</a> | 11/13/23 10:12 SC | | Mod | 0.20 | 0.14 | 30D |

1 Unit 1101 - Kitchen - Refrigerator - Nov 13 2023 10:12AM - [REDACTED]

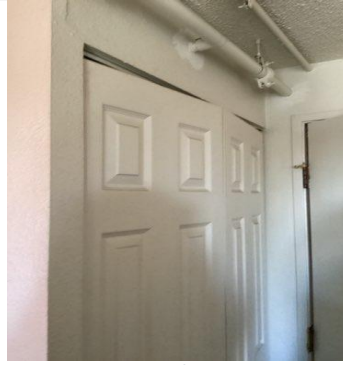
79

| Location | Item | Results | Notes | Pic | Date | Fixed | Sev | HUD Pts | Adj Pts | Fix By |
|---|---|---|---|---|---|---|---|---|---|---|
| Hallways & Corridors | Door – General | Closet door component is missing, damaged or inoperable | | <a href="#">79</a> | 11/13/23 10:01 SC | | Low | 0.09 | 0.06 | 60D |

1 Unit 1104 - Hallways & Corridors - Door – General - Nov 13 2023 10:01AM - [REDACTED]

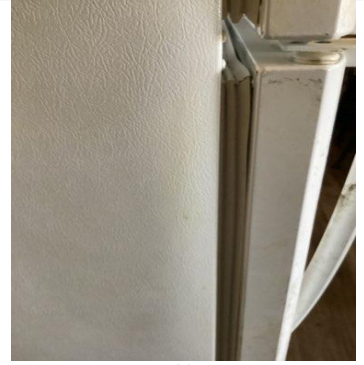
80

| Location | Item | Results | Notes | Pic | Date | Fixed | Sev | HUD Pts | Adj Pts | Fix By |
|---|---|---|---|---|---|---|---|---|---|---|
| Kitchen | Refrigerator | Refrigerator door seal is damaged | | <a href="#">80</a> | 11/13/23 10:05 SC | | Mod | 0.20 | 0.14 | 30D |

1 Unit 1104 - Kitchen - Refrigerator - Nov 13 2023 10:05AM - [REDACTED]
