## Results by Area

### NSPIRE: Other

Scheduled: 12/19/2023

Score: 89.33

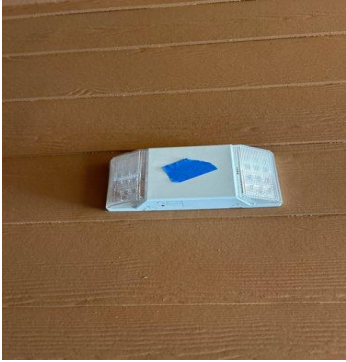
1

| Outside | | | | | | | | | | |
|---|---|---|---|---|---|---|---|---|---|---|
| Alternate Location - See Notes for Details | Lighting – Auxiliary | Auxiliary lighting component fails to illuminate when tested | Outside unit 216 | <u>1</u> | 12/19/23 12:31 SC | | Severe | 0.42 | 0.42 | 24H |

SR-2 - Alternate Location - See Notes for  
Details - Lighting – Auxiliary - Dec 19  
2023 12:31PM - [REDACTED] CAPTION:  
Outside unit 216

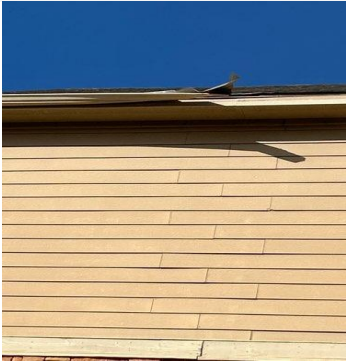
2

| Outside | | | | | | | | | | |
|---|---|---|---|---|---|---|---|---|---|---|
| Alternate Location - See Notes for Details | Roof Assembly | Roof assembly is damaged | | <u>2</u> | 12/19/23 14:00 SC | | Mod | 0.16 | 0.16 | 30D |

SR-4 - Alternate Location - See Notes for  
Details - Roof Assembly - Dec 19 2023  
2:00PM - [REDACTED]

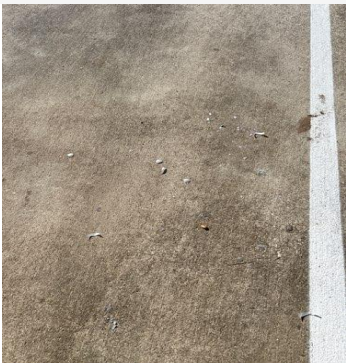
3

| Location | Item | Results | Notes | Pic | Date | Fixed | Sev | HUD Pts | Adj Pts | Fix By |
|---|---|---|---|---|---|---|---|---|---|---|
| Parking Lot | Sharp Edges | Any item or component has a sharp edge that can puncture or cut | | <u>3</u> | 12/19/23<br>14:34 SC | | Severe | 0.42 | 0.42 | 24H |

SR-5 - Parking Lot - Sharp Edges - Dec  
19 2023 2:34PM - [REDACTED]

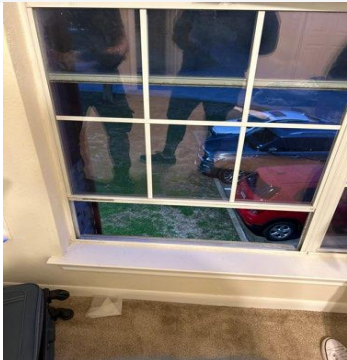
4

| Location | Item | Results | Notes | Pic | Date | Fixed | Sev | HUD Pts | Adj Pts | Fix By |
|---|---|---|---|---|---|---|---|---|---|---|
| Bedroom 1 | Window | A unit window screen has a hole, tear, or cut of more than one inch | | <u>4</u> | 12/19/23<br>17:43 SC | | Mod | 0.19 | 0.19 <sup>3</sup> | 30D |

SR-10 Unit 1027 - Bedroom 1 - Window -  
Dec 19 2023 5:43PM - [REDACTED]

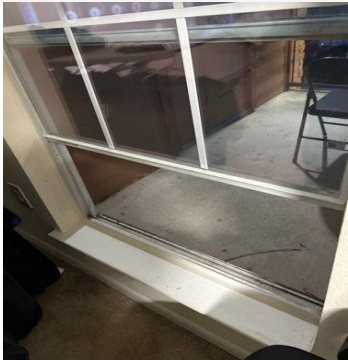
5

| Location | Item | Results | Notes | Pic | Date | Fixed | Sev | HUD Pts | Adj Pts | Fix By |
|---|---|---|---|---|---|---|---|---|---|---|
| Living Room | Window | A unit window screen has a hole, tear, or cut of more than one inch | | <u>5</u> | 12/19/23<br>17:45 SC | | Mod | 0.19 | 0.19 <sup>3</sup> | 30D |

SR-10 Unit 1027 - Living Room - Window  
- Dec 19 2023 5:45PM - [REDACTED]

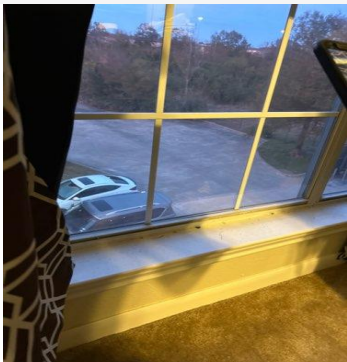
6

| Location | Item | Results | Notes | Pic | Date | Fixed | Sev | HUD Pts | Adj Pts | Fix By |
|---|---|---|---|---|---|---|---|---|---|---|
| Bedroom 1 | Window | A unit window screen has a hole, tear, or cut of more than one inch | | <u>6</u> | 12/19/23<br>17:36 SC | | Mod | 0.19 | 0.19 | 30D |

SR-10 Unit 1037 - Bedroom 1 - Window -  
Dec 19 2023 5:36PM - [REDACTED]

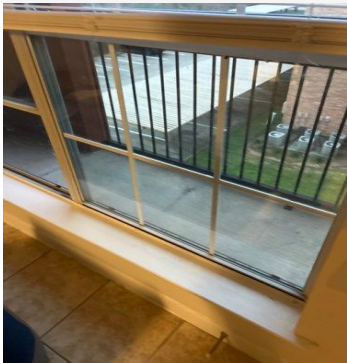
7

| Location | Item | Results | Notes | Pic | Date | Fixed | Sev | HUD Pts | Adj Pts | Fix By |
|---|---|---|---|---|---|---|---|---|---|---|
| Dining Room | Window | A unit window will not open or stay open | | <u>7</u> | 12/19/23<br>17:28 SC | | Mod | 0.19 | 0.19 | 30D |

SR-10 Unit 1038 - Dining Room - Window  
- Dec 19 2023 5:28PM - [REDACTED]

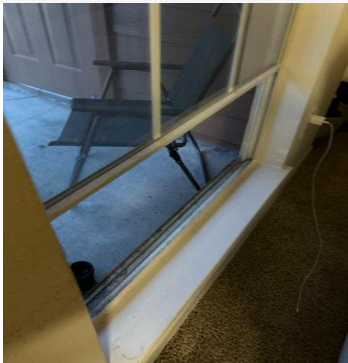
8

| Location | Item | Results | Notes | Pic | Date | Fixed | Sev | HUD Pts | Adj Pts | Fix By |
|---|---|---|---|---|---|---|---|---|---|---|
| Living Room | Window | A unit window screen has a hole, tear, or cut of more than one inch | | <u>8</u> | 12/19/23<br>17:26 SC | | Mod | 0.19 | 0.19 | 30D |

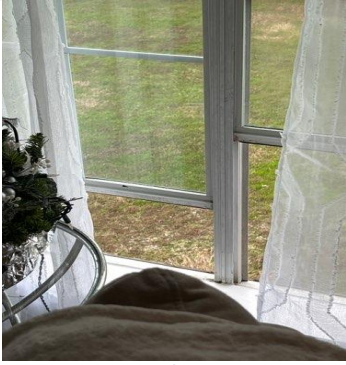
9

| Location | Item | Results | Notes | Pic | Date | Fixed | Sev | HUD Pts | Adj Pts | Fix By |
|---|---|---|---|---|---|---|---|---|---|---|
| Living Room | Window | A unit window screen has a hole, tear, or cut of more than one inch | | <u>9</u> | 12/19/23<br>16:36 SC | | Mod | 0.19 | 0.19 <sup>3</sup> | 30D |
| Living Room | Window | A unit window screen has a hole, tear, or cut of more than one inch | | <u>9</u> | 12/19/23<br>16:30 SC | | Mod | 0.19 | 0.19 <sup>3</sup> | 30D |

SR-11 Unit 1121 - Living Room - Window  
- Dec 19 2023 4:30PM - [REDACTED]

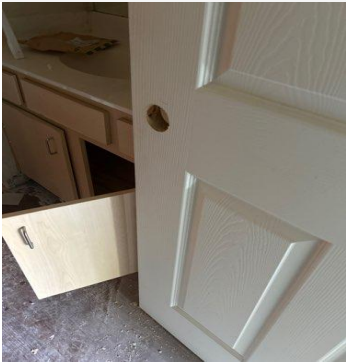
10

| Location | Item | Results | Notes | Pic | Date | Fixed | Sev | HUD Pts | Adj Pts | Fix By |
|---|---|---|---|---|---|---|---|---|---|---|
| Alternate Location - See Notes for Details | Door Hardware - Entry (non-fire) | Entry door component is damaged, inoperable, or missing (does not affect privacy or security) | | <a href="#">10</a> | 12/19/23<br>12:10 SC | | Low | 0.08 | 0.08 | 60D |

SR-2 Unit 0215 - Alternate Location - See  
Notes for Details - Door Hardware - Entry  
(non-fire) - Dec 19 2023 12:10PM - [REDACTED]

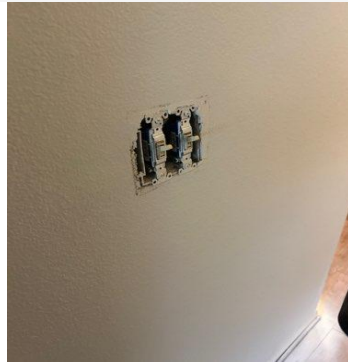
11

| Location | Item | Results | Notes | Pic | Date | Fixed | Sev | HUD Pts | Adj Pts | Fix By |
|---|---|---|---|---|---|---|---|---|---|---|
| Bathroom 2 | Conductors, Outlets, Switches | Exposed electrical conductor | | <a href="#">11</a> | 12/19/23<br>12:18 SC | | LT | 2.07 | 2.07 <sup>3</sup> | 24H |

SR-2 Unit 0215 - Bathroom 2 -  
Conductors, Outlets, Switches - Dec 19  
2023 12:18PM - [REDACTED]

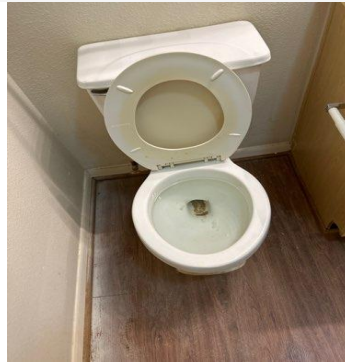
12

| Location | Item | Results | Notes | Pic | Date | Fixed | Sev | HUD Pts | Adj Pts | Fix By |
|---|---|---|---|---|---|---|---|---|---|---|
| Bathroom 2 | Toilet | Toilet components are damaged and inoperable | | <a href="#">12</a> | 12/19/23<br>12:17 SC | | Mod | 0.19 | 0.19 | 30D |

SR-2 Unit 0215 - Bathroom 2 - Toilet -  
Dec 19 2023 12:17PM - [REDACTED]

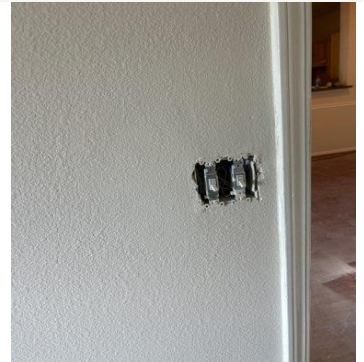
13

| Location | Item | Results | Notes | Pic | Date | Fixed | Sev | HUD Pts | Adj Pts | Fix By |
|---|---|---|---|---|---|---|---|---|---|---|
| Bedroom 2 | Conductors, Outlets, Switches | Exposed electrical conductor | | <a href="#">13</a> | 12/19/23<br>12:14 SC | | LT | 2.07 | 2.07 <sup>3</sup> | 24H |

SR-2 Unit 0215 - Bedroom 2 -  
Conductors, Outlets, Switches - Dec 19  
2023 12:14PM - [REDACTED]

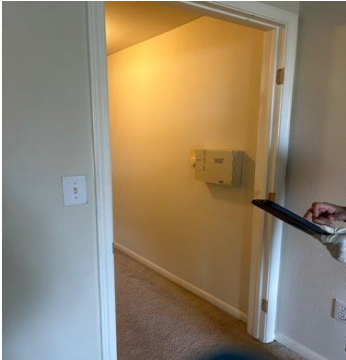
14

| Location | Item | Results | Notes | Pic | Date | Fixed | Sev | HUD Pts | Adj Pts | Fix By |
|---|---|---|---|---|---|---|---|---|---|---|
| Closet/Storage Area | Door - General | Closet door component is missing, damaged or inoperable | | <a href="#">14</a> | 12/19/23<br>12:15 SC | | Low | 0.08 | 0.08 | 60D |

SR-2 Unit 0215 - Closet/Storage Area -  
Door - General - Dec 19 2023 12:15PM - [REDACTED]

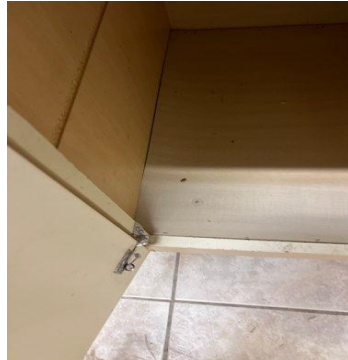
15

| Location | Item | Results | Notes | Pic | Date | Fixed | Sev | HUD Pts | Adj Pts | Fix By |
|---|---|---|---|---|---|---|---|---|---|---|
| Kitchen | Infestation | Evidence of cockroaches (Live, Dead, or Other Evidence) | | <a href="#">15</a> | 12/19/23<br>12:23 SC | | Mod | 0.19 | 0.19 | 30D |

SR-2 Unit 0215 - Kitchen - Infestation -  
Dec 19 2023 12:23PM - [REDACTED]

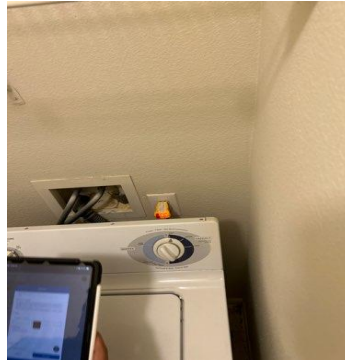
16

| Location | Item | Results | Notes | Pic | Date | Fixed | Sev | HUD Pts | Adj Pts | Fix By |
|---|---|---|---|---|---|---|---|---|---|---|
| Laundry Room | GFCI/AFCI | Missing GFCI protection on outlet within Six Feet of water source | | <a href="#">16</a> | 12/19/23<br>12:21 SC | | Severe | 0.00 | 0.00 <sup>2</sup> | 24H |

SR-2 Unit 0215 - Laundry Room -  
GFCI/AFCI - Dec 19 2023 12:21PM - [REDACTED]

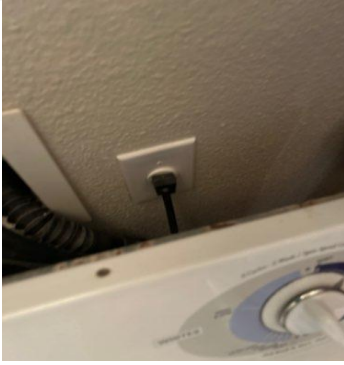
17

| Location | Item | Results | Notes | Pic | Date | Fixed | Sev | HUD Pts | Adj Pts | Fix By |
|---|---|---|---|---|---|---|---|---|---|---|
| Laundry Room | GFCI/AFCI | Missing GFCI protection on outlet within Six Feet of water source | | <a href="#">17</a> | 12/19/23<br>12:59 SC | | Severe | 0.00 | 0.00 <sup>2</sup> | 24H |

SR-3 Unit 0314 - Laundry Room -  
GFCI/AFCI - Dec 19 2023 12:59PM - [REDACTED]

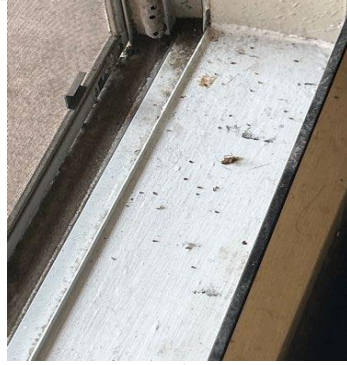
18

| Location | Item | Results | Notes | Pic | Date | Fixed | Sev | HUD Pts | Adj Pts | Fix By |
|---|---|---|---|---|---|---|---|---|---|---|
| Living Room | Infestation | Evidence of cockroaches (Live, Dead, or Other Evidence) | | <a href="#">18</a> | 12/19/23<br>12:56 SC | | Mod | 0.19 | 0.19 | 30D |

SR-3 Unit 0314 - Living Room -  
Infestation - Dec 19 2023 12:56PM - [REDACTED]

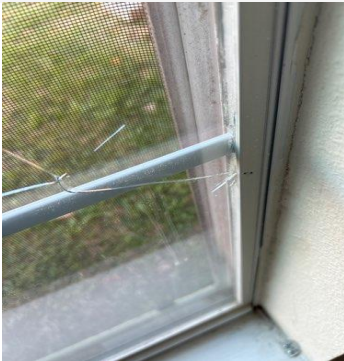
| Location | Item | Results | Notes | Pic | Date | Fixed | Sev | HUD Pts | Adj Pts | Fix By |
|---|---|---|---|---|---|---|---|---|---|---|
| Bedroom 1 | Sharp Edges | Any item or component has a sharp edge that can puncture or cut | | <a href="#">19</a> | 12/19/23 13:51 SC | | Severe | 0.51 | 0.51 | 24H |

SR-4 Unit 0412 - Bedroom 1 - Sharp  
Edges - Dec 19 2023 1:51PM - [REDACTED]

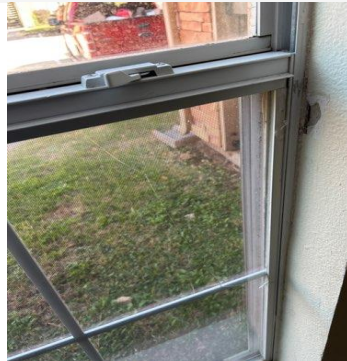
20

| Location | Item | Results | Notes | Pic | Date | Fixed | Sev | HUD Pts | Adj Pts | Fix By |
|---|---|---|---|---|---|---|---|---|---|---|
| Bedroom 1 | Window | A unit window pane, sash, or frame is damaged or missing | | <a href="#">20</a> | 12/19/23 13:50 SC | | Mod | 0.19 | 0.19 | 30D |

SR-4 Unit 0412 - Bedroom 1 - Window -  
Dec 19 2023 1:50PM - [REDACTED]

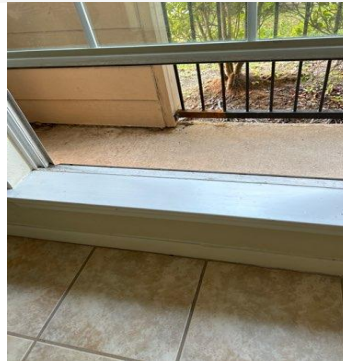
21

| Location | Item | Results | Notes | Pic | Date | Fixed | Sev | HUD Pts | Adj Pts | Fix By |
|---|---|---|---|---|---|---|---|---|---|---|
| Dining Room | Window | A unit window screen has a hole, tear, or cut of more than one inch | | <a href="#">21</a> | 12/19/23 13:49 SC | | Mod | 0.19 | 0.19 | 30D |

SR-4 Unit 0412 - Dining Room - Window  
- Dec 19 2023 1:49PM - [REDACTED]

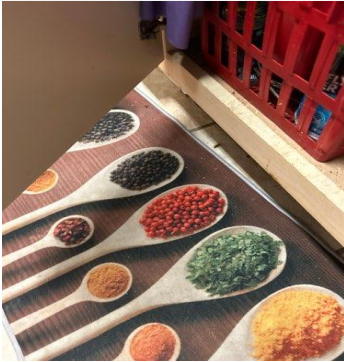
22

| Location | Item | Results | Notes | Pic | Date | Fixed | Sev | HUD Pts | Adj Pts | Fix By |
|---|---|---|---|---|---|---|---|---|---|---|
| Kitchen | Infestation | Evidence of cockroaches (Live, Dead, or Other Evidence) | | <a href="#">22</a> | 12/19/23 13:40 SC | | Mod | 0.19 | 0.19 | 30D |

SR-4 Unit 0415 - Kitchen - Infestation -  
Dec 19 2023 1:40PM - [REDACTED]

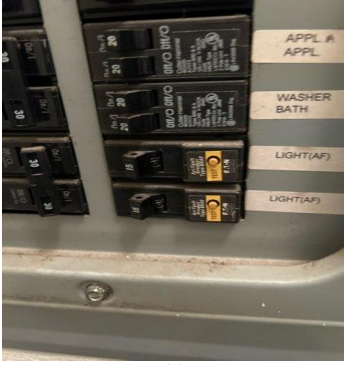
23

| Location | Item | Results | Notes | Pic | Date | Fixed | Sev | HUD Pts | Adj Pts | Fix By |
|---|---|---|---|---|---|---|---|---|---|---|
| Alternate Location - See Notes for Details | GFCI/AFCI | GFCI outlet or GFCI breaker reset button does not test (No visible damage) | Service panel | <a href="#">23</a> | 12/19/23 13:30 SC | | Severe | 0.51 | 0.51 | 24H |

SR-4 Unit 0418 - Alternate Location - See Notes for Details - GFCI/AFCI - Dec 19 2023 1:30PM - [REDACTED] CAPTION: Service panel

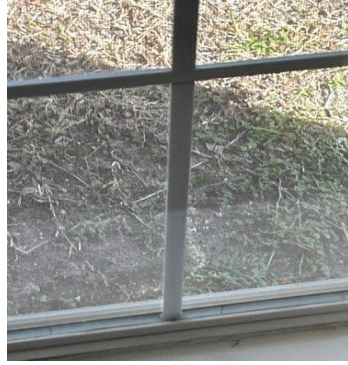
24

| Location | Item | Results | Notes | Pic | Date | Fixed | Sev | HUD Pts | Adj Pts | Fix By |
|---|---|---|---|---|---|---|---|---|---|---|
| Bedroom 1 | Window | A unit window screen has a hole, tear, or cut of more than one inch | | <a href="#">24</a> | 12/19/23 13:34 SC | | Mod | 0.19 | 0.19 | 30D |

SR-4 Unit 0418 - Bedroom 1 - Window - Dec 19 2023 1:34PM - [REDACTED]

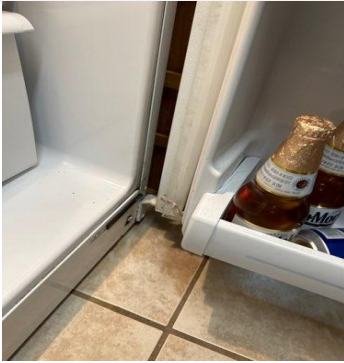
25

| Location | Item | Results | Notes | Pic | Date | Fixed | Sev | HUD Pts | Adj Pts | Fix By |
|---|---|---|---|---|---|---|---|---|---|---|
| Kitchen | Refrigerator | Refrigerator door seal is damaged | | <a href="#">25</a> | 12/19/23 13:22 SC | | Mod | 0.19 | 0.19 | 30D |

SR-4 Unit 0428 - Kitchen - Refrigerator - Dec 19 2023 1:22PM - [REDACTED]

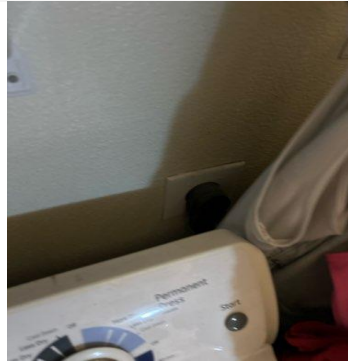
26

| Location | Item | Results | Notes | Pic | Date | Fixed | Sev | HUD Pts | Adj Pts | Fix By |
|---|---|---|---|---|---|---|---|---|---|---|
| Laundry Room | GFCI/AFCI | Missing GFCI protection on outlet within Six Feet of water source | | <a href="#">26</a> | 12/19/23 13:18 SC | | Severe | 0.00 | 0.00 <sup>2</sup> | 24H |

SR-4 Unit 0428 - Laundry Room - GFCI/AFCI - Dec 19 2023 1:18PM - [REDACTED]

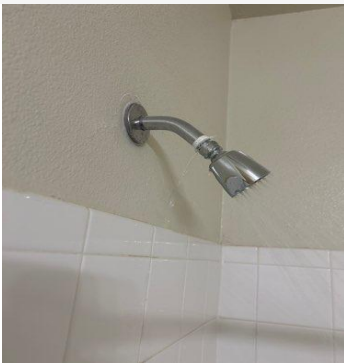
27

| Location | Item | Results | Notes | Pic | Date | Fixed | Sev | HUD Pts | Adj Pts | Fix By |
|---|---|---|---|---|---|---|---|---|---|---|
| Bathroom 1 | Bathtub/Shower | Bath/shower components damaged, missing, or inoperable | | <a href="#">27</a> | 12/19/23 14:23 SC | | Mod | 0.19 | 0.19 | 30D |

SR-5 Unit 0524 - Bathroom 1 - Bathtub/Shower - Dec 19 2023 2:23PM - [REDACTED]

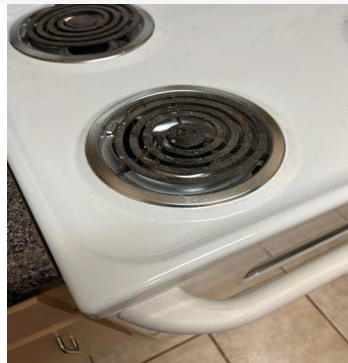
28

| Location | Item | Results | Notes | Pic | Date | Fixed | Sev | HUD Pts | Adj Pts | Fix By |
|---|---|---|---|---|---|---|---|---|---|---|
| Kitchen | Cooking Appliance | A Stove Burner is Inoperable (with at least one operable burner) | | <a href="#">28</a> | 12/19/23 14:20 SC | | Mod | 0.19 | 0.19 | 30D |

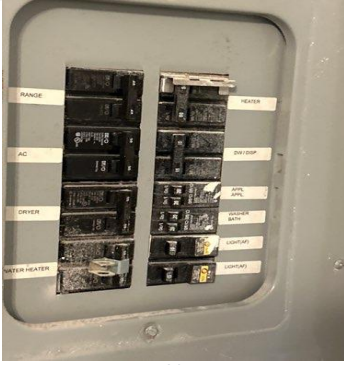
29

| Location | Item | Results | Notes | Pic | Date | Fixed | Sev | HUD Pts | Adj Pts | Fix By |
|---|---|---|---|---|---|---|---|---|---|---|
| Alternate Location - See Notes for Details | GFCI/AFCI | GFCI outlet or GFCI breaker reset button does not test (No visible damage) | Service panel | <a href="#">29</a> | 12/19/23 14:12 SC | | Severe | 0.51 | 0.51 | 24H |

SR-5 Unit 0534 - Alternate Location - See  
Notes for Details - GFCI/AFCI - Dec 19  
2023 2:12PM - [REDACTED] CAPTION:  
Service panel

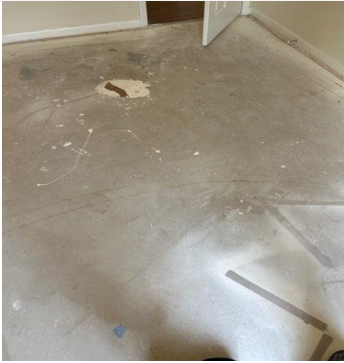
30

| Location | Item | Results | Notes | Pic | Date | Fixed | Sev | HUD Pts | Adj Pts | Fix By |
|---|---|---|---|---|---|---|---|---|---|---|
| Bedroom 1 | Floor Covering and Finish | 10% or more of the floor substrate area is exposed in any room | | <a href="#">30</a> | 12/19/23 15:20 SC | | Mod | 0.19 | 0.19 | 30D |

SR-6 Unit 0616 - Bedroom 1 - Floor  
Covering and Finish - Dec 19 2023  
3:20PM - [REDACTED]

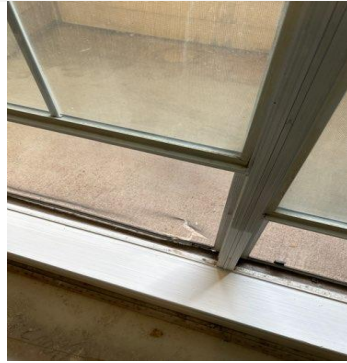
31

| Location | Item | Results | Notes | Pic | Date | Fixed | Sev | HUD Pts | Adj Pts | Fix By |
|---|---|---|---|---|---|---|---|---|---|---|
| Bedroom 1 | Window | A unit window screen has a hole, tear, or cut of more than one inch | | <a href="#">31</a> | 12/19/23 15:19 SC | | Mod | 0.19 | 0.19 | 30D |

SR-6 Unit 0616 - Bedroom 1 - Window -  
Dec 19 2023 3:19PM - [REDACTED]

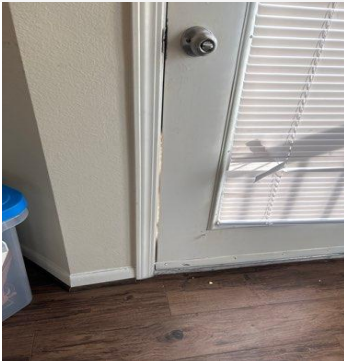
32

| Location | Item | Results | Notes | Pic | Date | Fixed | Sev | HUD Pts | Adj Pts | Fix By |
|---|---|---|---|---|---|---|---|---|---|---|
| Alternate Location - See Notes for Details | Door Surface - Entry (non-fire) | Gap of 1/4" around door seal/gasket & light penetration | | <a href="#">32</a> | 12/19/23 15:35 SC | | Mod | 0.19 | 0.19 | 30D |

SR-6 Unit 0632 - Alternate Location - See  
Notes for Details - Door Surface - Entry  
(non-fire) - Dec 19 2023 3:35PM - [REDACTED]

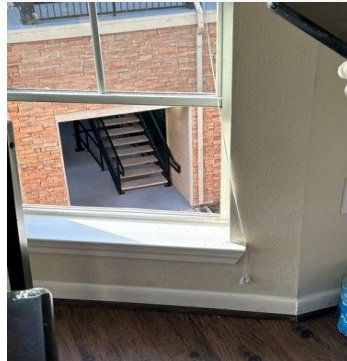
33

| Location | Item | Results | Notes | Pic | Date | Fixed | Sev | HUD Pts | Adj Pts | Fix By |
|---|---|---|---|---|---|---|---|---|---|---|
| Dining Room | Window | A unit window screen has a hole, tear, or cut of more than one inch | | <a href="#">33</a> | 12/19/23 15:33 SC | | Mod | 0.19 | 0.19 | 30D |

SR-6 Unit 0632 - Dining Room - Window  
- Dec 19 2023 3:33PM - [REDACTED]

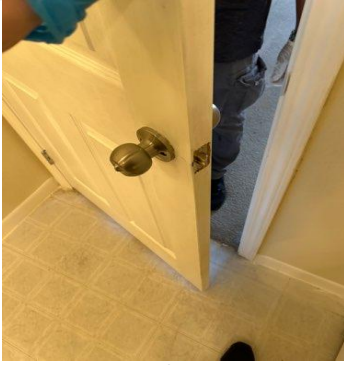
34

| Location | Item | Results | Notes | Pic | Date | Fixed | Sev | HUD Pts | Adj Pts | Fix By |
|---|---|---|---|---|---|---|---|---|---|---|
| Bathroom 2 | Door – General | A passage door component is damaged/missing/inoperable | | <a href="#">34</a> | 12/19/23 14:44 SC | | Low | 0.08 | 0.08 | 60D |

SR-6 Unit 0637 - Bathroom 2 - Door –  
General - Dec 19 2023 2:44PM - [REDACTED]

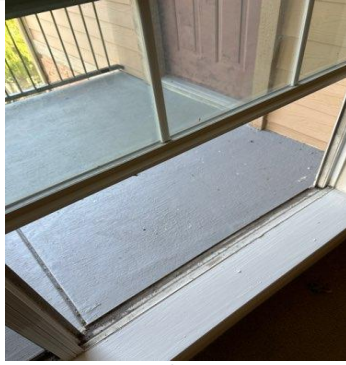
35

| Location | Item | Results | Notes | Pic | Date | Fixed | Sev | HUD Pts | Adj Pts | Fix By |
|---|---|---|---|---|---|---|---|---|---|---|
| Bedroom 1 | Window | A unit window screen has a hole, tear, or cut of more than one inch | | <a href="#">35</a> | 12/19/23 14:40 SC | | Mod | 0.19 | 0.19 | 30D |

SR-6 Unit 0637 - Bedroom 1 - Window -  
Dec 19 2023 2:40PM - [REDACTED]

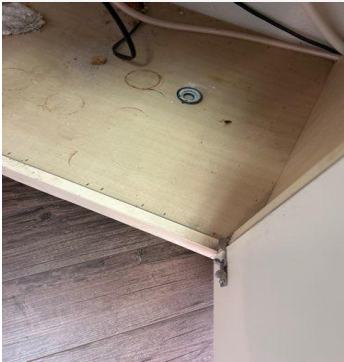
36

| Location | Item | Results | Notes | Pic | Date | Fixed | Sev | HUD Pts | Adj Pts | Fix By |
|---|---|---|---|---|---|---|---|---|---|---|
| Kitchen | Infestation | Evidence of cockroaches (Live, Dead, or Other Evidence) | | <a href="#">36</a> | 12/19/23 15:56 SC | | Mod | 0.19 | 0.19 | 30D |

SR-7 Unit 0737 - Kitchen - Infestation -  
Dec 19 2023 3:56PM - [REDACTED]

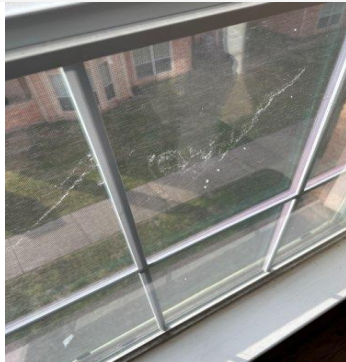
37

| Location | Item | Results | Notes | Pic | Date | Fixed | Sev | HUD Pts | Adj Pts | Fix By |
|---|---|---|---|---|---|---|---|---|---|---|
| Living Room | Window | A unit window screen has a hole, tear, or cut of more than one inch | | <a href="#">37</a> | 12/19/23 15:53 SC | | Mod | 0.19 | 0.19 | 30D |

SR-7 Unit 0737 - Living Room - Window -  
Dec 19 2023 3:53PM - [REDACTED]

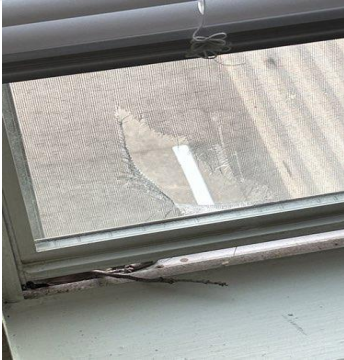
38

| Location | Item | Results | Notes | Pic | Date | Fixed | Sev | HUD Pts | Adj Pts | Fix By |
|---|---|---|---|---|---|---|---|---|---|---|
| Dining Room | Window | A unit window screen has a hole, tear, or cut of more than one inch | | <a href="#">38</a> | 12/19/23 16:09 SC | | Mod | 0.19 | 0.19 | 30D |

SR-7 Unit 0738 - Dining Room - Window  
- Dec 19 2023 4:09PM - [REDACTED]

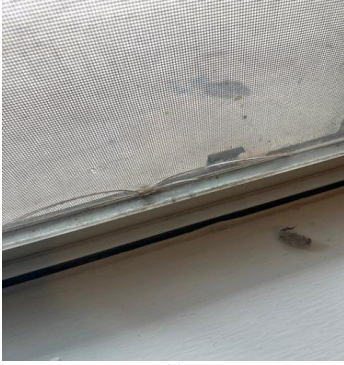
39

| Location | Item | Results | Notes | Pic | Date | Fixed | Sev | HUD Pts | Adj Pts | Fix By |
|---|---|---|---|---|---|---|---|---|---|---|
| Bedroom 1 | Window | A unit window pane, sash, or frame is damaged or missing | | <a href="#">39</a> | 12/20/23 10:02 SC | | Mod | 0.19 | 0.19 | 30D |

SR-8 Unit 0823 - Bedroom 1 - Window -  
Dec 20 2023 10:02AM - [REDACTED]

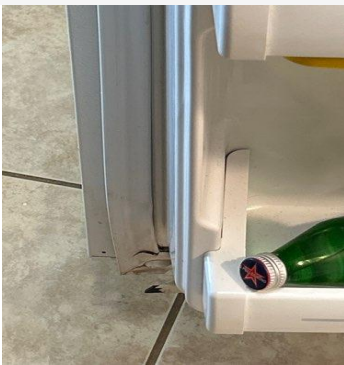
40

| Location | Item | Results | Notes | Pic | Date | Fixed | Sev | HUD Pts | Adj Pts | Fix By |
|---|---|---|---|---|---|---|---|---|---|---|
| Kitchen | Refrigerator | Refrigerator door seal is damaged | | <a href="#">40</a> | 12/20/23 10:16 SC | | Mod | 0.19 | 0.19 | 30D |

SR-8 Unit 0826 - Kitchen - Refrigerator -  
Dec 20 2023 10:16AM - [REDACTED]

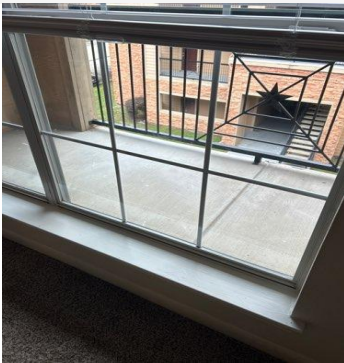
41

| Location | Item | Results | Notes | Pic | Date | Fixed | Sev | HUD Pts | Adj Pts | Fix By |
|---|---|---|---|---|---|---|---|---|---|---|
| Living Room | Window | A unit window screen has a hole, tear, or cut of more than one inch | | <a href="#">41</a> | 12/20/23 09:55 SC | | Mod | 0.19 | 0.19 | 30D |

SR-8 Unit 0833 - Living Room - Window -  
Dec 20 2023 9:55AM - [REDACTED]

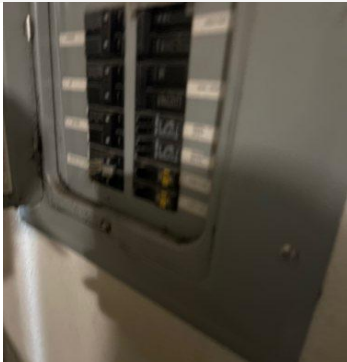
42

| Location | Item | Results | Notes | Pic | Date | Fixed | Sev | HUD Pts | Adj Pts | Fix By |
|---|---|---|---|---|---|---|---|---|---|---|
| Bedroom 1 | GFCI/AFCI | GFCI outlet or GFCI breaker reset button does not test (No visible damage) | | <a href="#">42</a> | 12/19/23 17:09 SC | | Severe | 0.51 | 0.51 | 24H |

SR-9 Unit 0917 - Bedroom 1 - GFCI/AFCI  
- Dec 19 2023 5:09PM - [REDACTED]

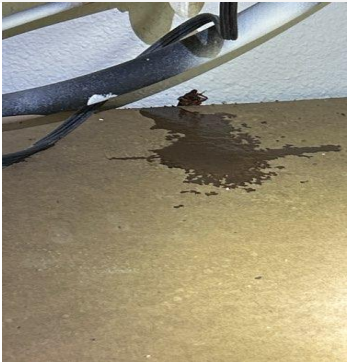
43

| Location | Item | Results | Notes | Pic | Date | Fixed | Sev | HUD Pts | Adj Pts | Fix By |
|---|---|---|---|---|---|---|---|---|---|---|
| Kitchen | Infestation | Evidence of cockroaches (Live, Dead, or Other Evidence) | | <a href="#">43</a> | 12/19/23 17:07 SC | | Mod | 0.19 | 0.19 | 30D |

SR-9 Unit 0917 - Kitchen - Infestation -  
Dec 19 2023 5:07PM - [REDACTED]
