### NSPIRE: Other

Scheduled: 11/13/2023

Score: 57.88

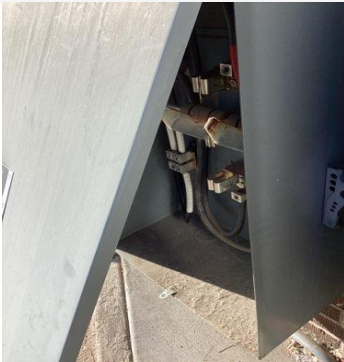
| Outside | | | | | | | | | | | |
|---|---|---|---|---|---|---|---|---|---|---|---|
| | Exterior Wall | Conductors, Outlets, Switches | Exposed electrical conductor | Back East side of building, needs zipties | <u>1</u> | 11/13/23 13:56 SC | | LT | 1.77 | 1.27 | 24H |

1 - Exterior Wall - Conductors, Outlets, Switches - Nov 13 2023 1:56PM - [REDACTED] CAPTION: Back East side of building, needs zip ties

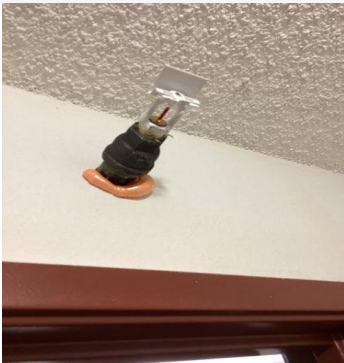
5

1 - Hallways & Corridors (Bldg) - Sprinkler Assembly - Nov 13 2023 10:35AM - [REDACTED] CAPTION: 10th floor storage room

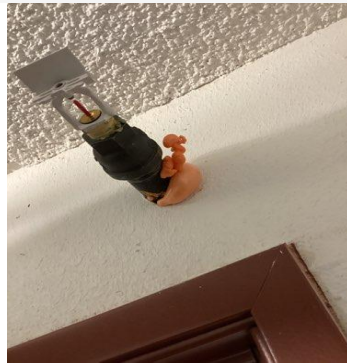
6

1 - Hallways & Corridors (Bldg) - Sprinkler Assembly - Nov 13 2023 10:06AM - [REDACTED] CAPTION: 11th floor main breaker room 2

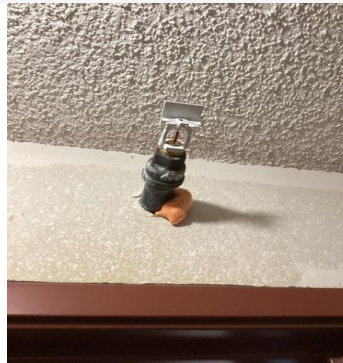
7

1 - Local Systems (Bldg) - Sprinkler Assembly - Nov 13 2023 10:58AM - [REDACTED] CAPTION: 9th floor electrical room

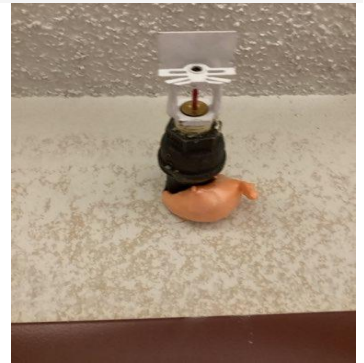
8

1 - Local Systems (Bldg) - Sprinkler Assembly - Nov 13 2023 9:45AM - [REDACTED] CAPTION: 11th floor Main breaker room

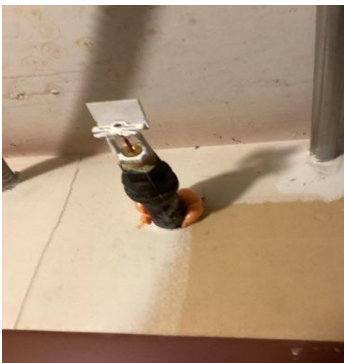
11

1 - Local Systems (Bldg) - Sprinkler Assembly - Nov 13 2023 1:16PM - [REDACTED] CAPTION: 3rd floor electrical room

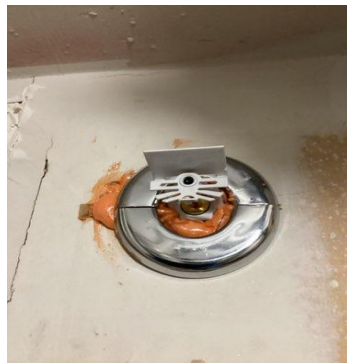
9

1 - Local Systems (Bldg) - Sprinkler Assembly - Nov 13 2023 1:23PM - [REDACTED] CAPTION: 2nd floor main breaker room

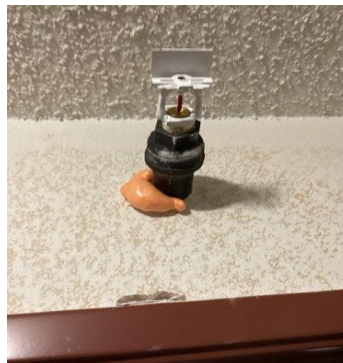
10

1 - Local Systems (Bldg) - Sprinkler Assembly - Nov 13 2023 10:47AM - [REDACTED] CAPTION: 9th floor electric room

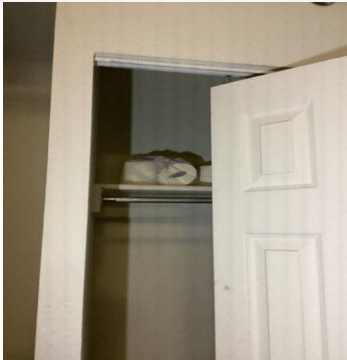
12

1 Unit 0104 - Closet/Storage Area - Door  
- General - Nov 13 2023 1:35PM -

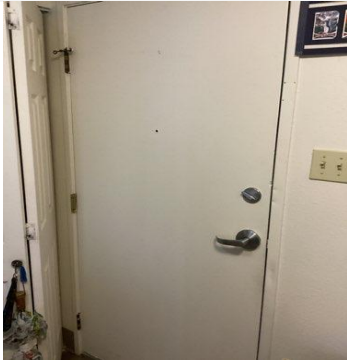
14

1 Unit 0212 - Alternate Location - See  
Notes for Details - Door Hardware - Entry  
(non-fire) - Nov 13 2023 1:24PM -

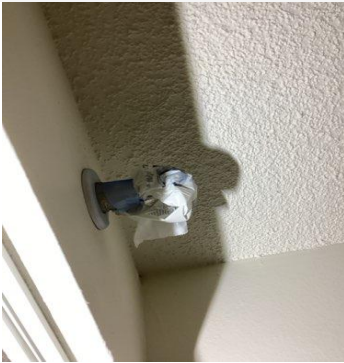
20

1 Unit 0307 - Hallways & Corridors - Sprinkler Assembly - Nov 13 2023 1:11PM - [REDACTED]

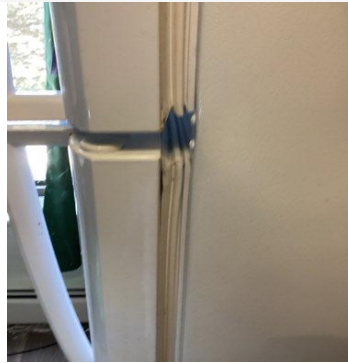
21

1 Unit 0307 - Kitchen - Refrigerator - Nov 13 2023 1:09PM - [REDACTED]

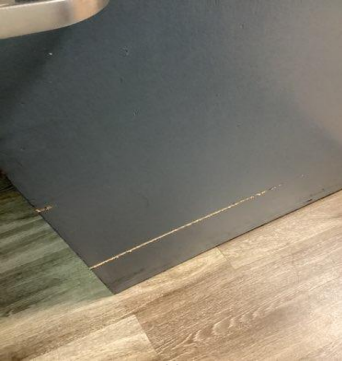
22

1 Unit 0310 - Alternate Location - See Notes for Details - Door Surface - Entry (non-fire) - Nov 13 2023 1:13PM - [REDACTED]

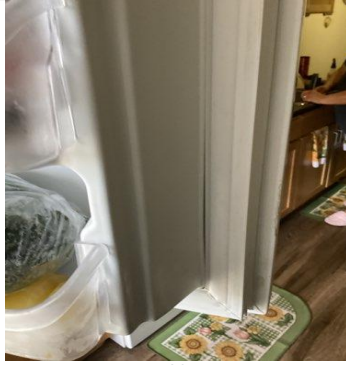
23

1 Unit 0310 - Kitchen - Refrigerator - Nov 13 2023 1:14PM - [REDACTED]

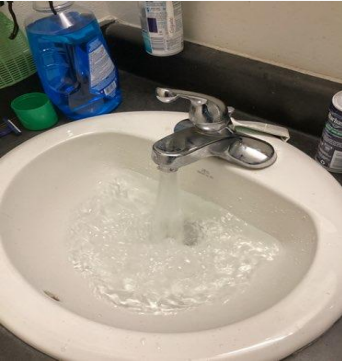
24

1 Unit 0401 - Bathroom 1 - Sink - Nov 13 2023 1:01PM - [REDACTED]

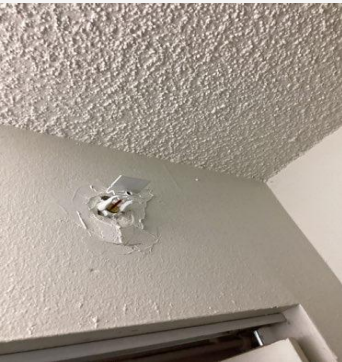
25

1 Unit 0406 - Hallways & Corridors - Sprinkler Assembly - Nov 13 2023 12:54PM - [REDACTED]

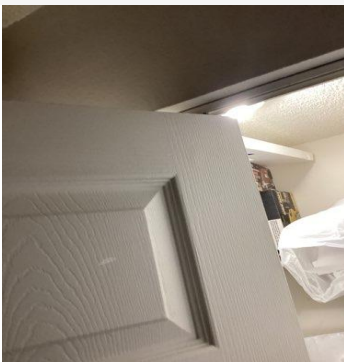
29

1 Unit 0603 - Hallways & Corridors - Door  
- General - Nov 13 2023 11:41AM - [REDACTED]

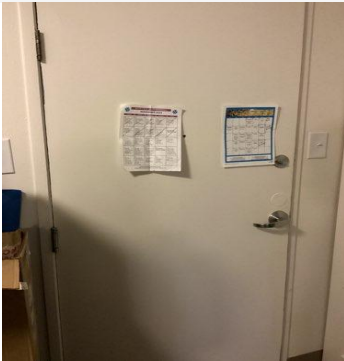
33

1 Unit 0610 - Alternate Location - See Notes for Details - Door Hardware - Entry (non-fire) - Nov 13 2023 11:46AM - [REDACTED]

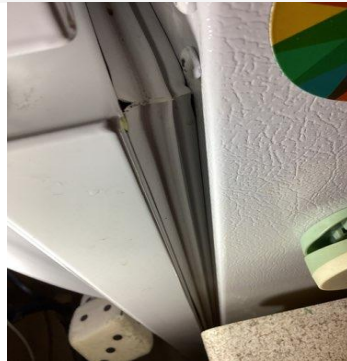
34

1 Unit 0610 - Kitchen - Refrigerator - Nov 13 2023 11:48AM - [REDACTED]

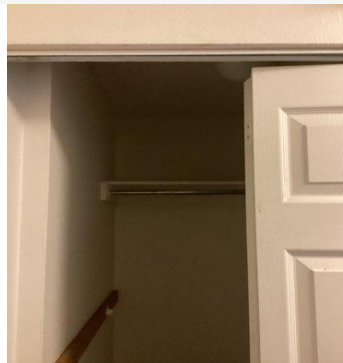
37

1 Unit 0712 - Closet/Storage Area - Door - General - Nov 13 2023 11:20AM - [REDACTED]

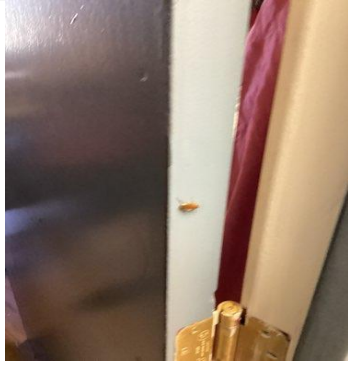
45

1 Unit 0813 - Living Room - Infestation -  
Nov 13 2023 11:10AM - [REDACTED]

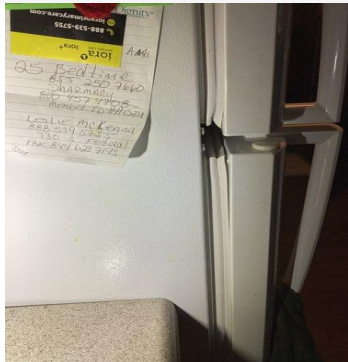
48

1 Unit 0903 - Kitchen - Refrigerator - Nov  
13 2023 10:54AM - [REDACTED]

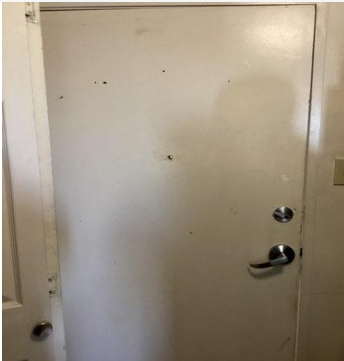
52

| Location | Item | Results | Notes | Pic | Date | Fixed | Sev | HUD Pts | Adj Pts | Fix By |
|---|---|---|---|---|---|---|---|---|---|---|
| Alternate Location - See Notes for Details | Door Hardware - Entry (non-fire) | Entry door self-closing mechanism is damaged or inoperable | | <a href="#">52</a> | 11/13/23 10:16 SC | | Mod | 0.20 | 0.14 | 30D |

1 Unit 1004 - Alternate Location - See Notes for Details - Door Hardware - Entry (non-fire) - Nov 13 2023 10:16AM - [REDACTED]

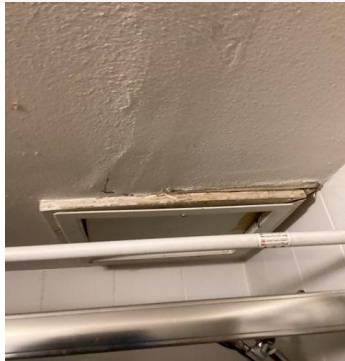
53

1 Unit 1004 - Bathroom 1 - Ceiling Covering and Finishes - Nov 13 2023 10:17AM - [REDACTED]

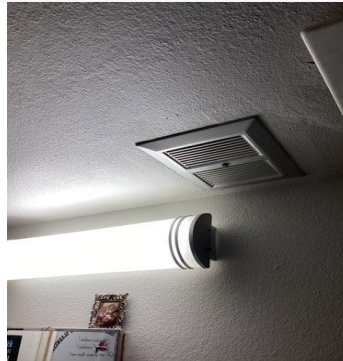
54

1 Unit 1004 - Bathroom 1 - Exhaust System - Nov 13 2023 10:17AM - [REDACTED]

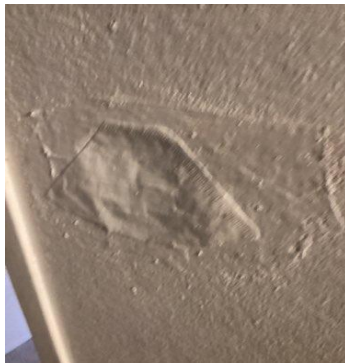
57

1 Unit 1004 - Hallways & Corridors - Wall Covering and Finish - Interior - Nov 13 2023 10:18AM - [REDACTED]

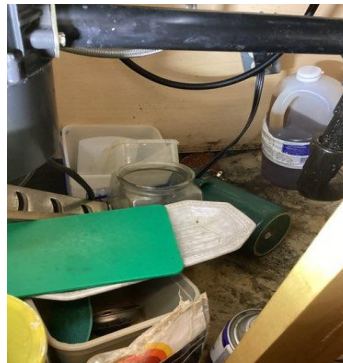
58

| Location | Item | Results | Notes | Pic | Date | Fixed | Sev | HUD Pts | Adj Pts | Fix By |
|---|---|---|---|---|---|---|---|---|---|---|
| Kitchen | Cabinetry | More than 25% of cabinets are missing | | <a href="#">58</a> | 11/13/23 10:20 SC | | Mod | 0.20 | 0.14 | 30D |

1 Unit 1004 - Kitchen - Cabinetry - Nov 13 2023 10:20AM - [REDACTED]

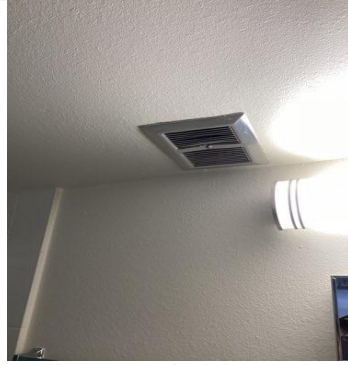
61

1 Unit 1006 - Bathroom 1 - Exhaust System - Nov 13 2023 10:24AM - [REDACTED]

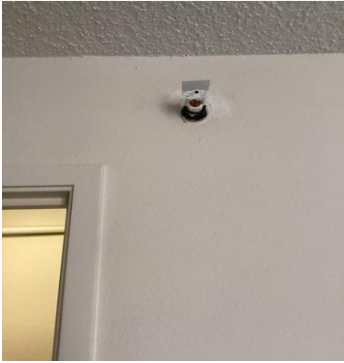
70

| Location | Item | Results | Notes | Pic | Date | Fixed | Sev | HUD Pts | Adj Pts | Fix By |
|---|---|---|---|---|---|---|---|---|---|---|
| Bedroom 1 | Sprinkler Assembly | Sprinkler assembly component is missing or damaged | | <a href="#">70</a> | 11/13/23 10:42 SC | | LT | 2.14 | 1.54 | 24H |

1 Unit 1016 - Bedroom 1 - Sprinkler Assembly - Nov 13 2023 10:42AM - [REDACTED]

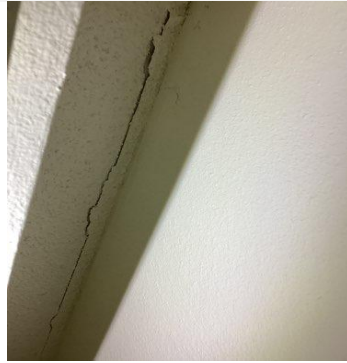
71

1 Unit 1016 - Closet/Storage Area - Ceiling Covering and Finishes - Nov 13 2023 10:43AM - [REDACTED]

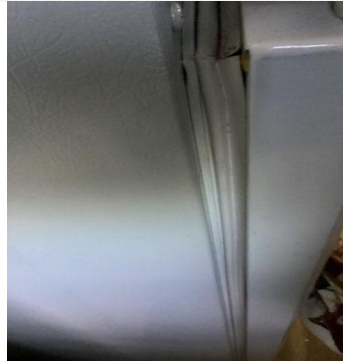
72

| Location | Item | Results | Notes | Pic | Date | Fixed | Sev | HUD Pts | Adj Pts | Fix By |
|---|---|---|---|---|---|---|---|---|---|---|
| Kitchen | Refrigerator | Refrigerator door seal is damaged | | <a href="#">72</a> | 11/13/23 10:41 SC | | Mod | 0.20 | 0.14 | 30D |

1 Unit 1016 - Kitchen - Refrigerator - Nov 13 2023 10:41AM - [REDACTED]

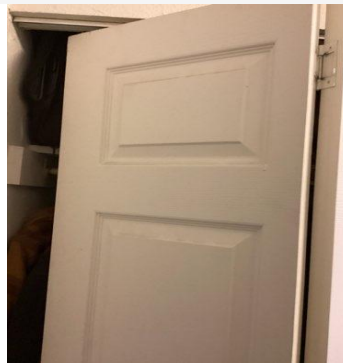
75

| Location | Item | Results | Notes | Pic | Date | Fixed | Sev | HUD Pts | Adj Pts | Fix By |
|---|---|---|---|---|---|---|---|---|---|---|
| Hallways & Corridors | Door – General | Closet door component is missing, damaged or inoperable | | <a href="#">75</a> | 11/13/23 10:11 SC | | Low | 0.09 | 0.06 | 60D |

1 Unit 1101 - Hallways & Corridors - Door - General - Nov 13 2023 10:11AM - [REDACTED]

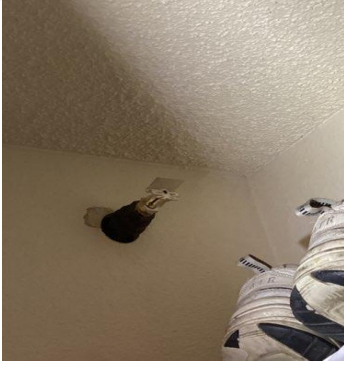
77

1 Unit 1104 - Bedroom 1 - Sprinkler Assembly - Nov 13 2023 10:03AM - [REDACTED]

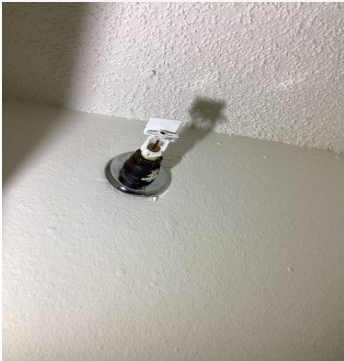
81

1 Unit 1110 - Bedroom 1 - Sprinkler Assembly - Nov 13 2023 9:58AM - [REDACTED]

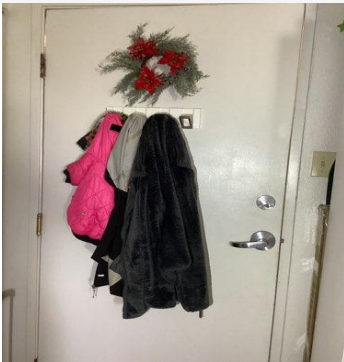
82

| Location | Item | Results | Notes | Pic | Date | Fixed | Sev | HUD Pts | Adj Pts | Fix By |
|---|---|---|---|---|---|---|---|---|---|---|
| Alternate Location - See Notes for Details | Door Hardware - Entry (non-fire) | Entry door self-closing mechanism is damaged or inoperable | | <a href="#">82</a> | 11/13/23 09:46 SC | | Mod | 0.20 | 0.14 | 30D |

1 Unit 1112 - Alternate Location - See Notes for Details - Door Hardware - Entry (non-fire) - Nov 13 2023 9:46AM - [REDACTED]

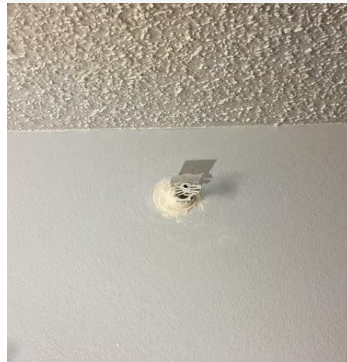
83

1 Unit 1112 - Alternate Location - See Notes for Details - Sprinkler Assembly - Nov 13 2023 9:51AM - [REDACTED]  
CAPTION: Living room

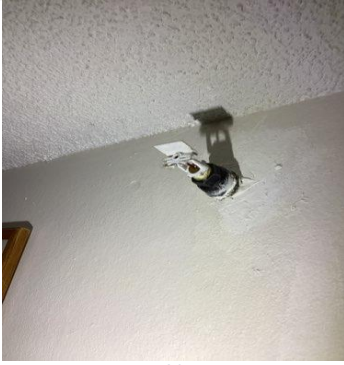
86

1 Unit 1112 - Bedroom 1 - Sprinkler Assembly - Nov 13 2023 9:50AM - [REDACTED]

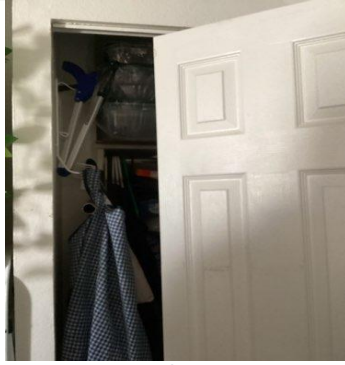
87

| Location | Item | Results | Notes | Pic | Date | Fixed | Sev | HUD Pts | Adj Pts | Fix By |
|---|---|---|---|---|---|---|---|---|---|---|
| Closet/Storage Area | Door – General | Closet door component is missing, damaged or inoperable | | <a href="#">87</a> | 11/13/23 09:47 SC | | Low | 0.09 | 0.06 | 60D |

1 Unit 1112 - Closet/Storage Area - Door - General - Nov 13 2023 9:47AM - [REDACTED]

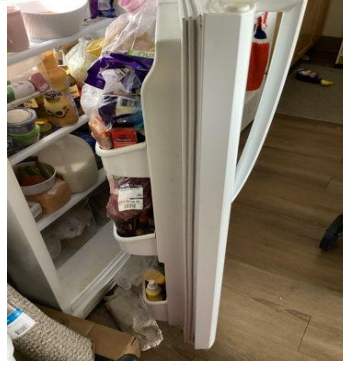
88

| Location | Item | Results | Notes | Pic | Date | Fixed | Sev | HUD Pts | Adj Pts | Fix By |
|---|---|---|---|---|---|---|---|---|---|---|
| Kitchen | Refrigerator | Refrigerator door seal is damaged | | <a href="#">88</a> | 11/13/23 09:53 SC | | Mod | 0.20 | 0.14 | 30D |

1 Unit 1112 - Kitchen - Refrigerator - Nov 13 2023 9:53AM - [REDACTED]

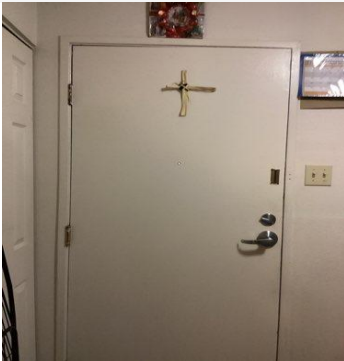
89

| Location | Item | Results | Notes | Pic | Date | Fixed | Sev | HUD Pts | Adj Pts | Fix By |
|---|---|---|---|---|---|---|---|---|---|---|
| Alternate Location - See Notes for Details | Door Hardware - Entry (non-fire) | Entry door self-closing mechanism is damaged or inoperable | | <a href="#">89</a> | 11/13/23 09:29 SC | | Mod | 0.20 | 0.14 | 30D |

1 Unit 1205 - Alternate Location - See Notes for Details - Door Hardware - Entry (non-fire) - Nov 13 2023 9:29AM - [REDACTED]

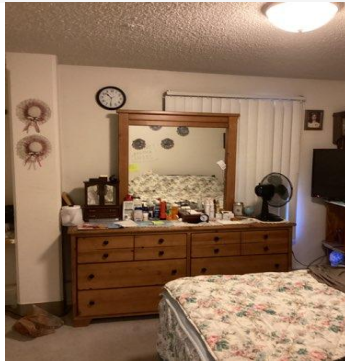
90

1 Unit 1205 - Bedroom 1 - Egress - Nov 13 2023 9:35AM - [REDACTED]

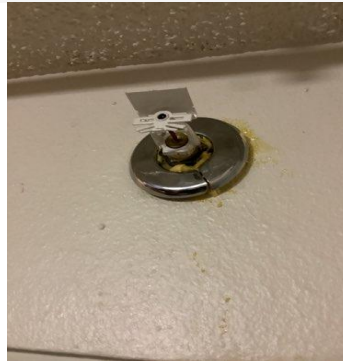
91

1 Unit 1205 - Hallways & Corridors - Sprinkler Assembly - Nov 13 2023 9:33AM - [REDACTED]

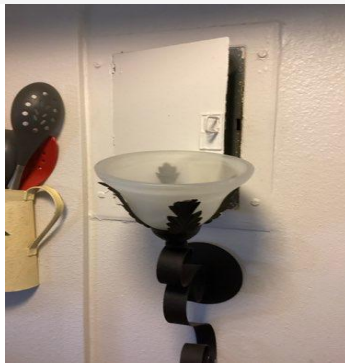
93

1 Unit 1207 - Local Systems - Service Panel - Nov 13 2023 9:39AM - [REDACTED]

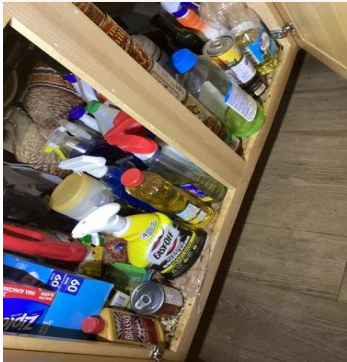
94

1 Unit 1302 - Kitchen - Infestation - Nov 13 2023 9:23AM - [REDACTED]

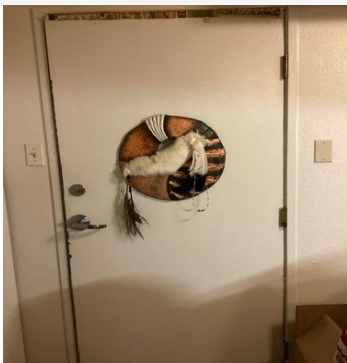
95

| Location | Item | Results | Notes | Pic | Date | Fixed | Sev | HUD Pts | Adj Pts | Fix By |
|---|---|---|---|---|---|---|---|---|---|---|
| Alternate Location - See Notes for Details | Door Hardware - Entry (non-fire) | Entry door self-closing mechanism is damaged or inoperable | | <a href="#">95</a> | 11/13/23 09:16 SC | | Mod | 0.20 | 0.14 | 30D |

1 Unit 1308 - Alternate Location - See Notes for Details - Door Hardware - Entry (non-fire) - Nov 13 2023 9:16AM - [REDACTED]

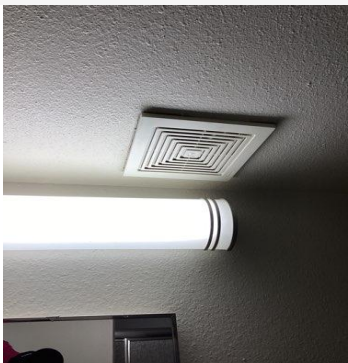
96

1 Unit 1308 - Bathroom 1 - Exhaust System - Nov 13 2023 9:18AM - [REDACTED]

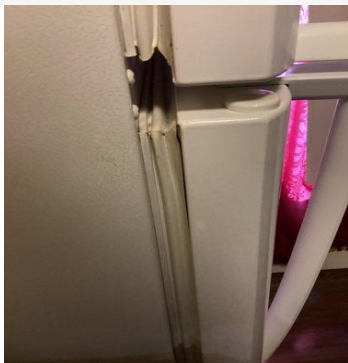
| Location | Item | Results | Notes | Pic | Date | Fixed | Sev | HUD<br>Pts | Adj Pts | Fix By |
|---|---|---|---|---|---|---|---|---|---|---|
| Kitchen | Refrigerator | Refrigerator door seal is damaged | | 97 | 11/13/23<br>09:19 SC | | Mod | 0.20 | 0.14 | 30D |

1 Unit 1308 - Kitchen - Refrigerator - Nov 13 2023 9:19AM - [REDACTED]
